Subject: UDOT Project Number F-0191(152)126, US-191, North Moab to Colorado River Bridge,
Grand County, Utah (PIN 15329)
Environmental Assessment Re-evaluation

A Final Environmental Assessment (EA) and Programmatic Section 4(f) Evaluation for the US-191 Colorado Bridge For Bridge/Roadway Reconstruction and Widening on US-191, from 400 North in Moab City to SR-279 (Potash Road), Grand County, was completed (2007) and approved through the issuance of a Finding of No Significant Impact (FONSI) (May 25, 2007) from the Federal Highway Administration (FHWA). Design modifications for the current phase between State Route 128 (SR-128) and 400 North in Moab, Grand County were not included in the 2007 EA and are the subject of this EA Re-evaluation. These improvements include a new stormwater collection system, three sedimentation basins, a vegetated water quality swale, a sedimentation dropout channel, and several new outfalls.

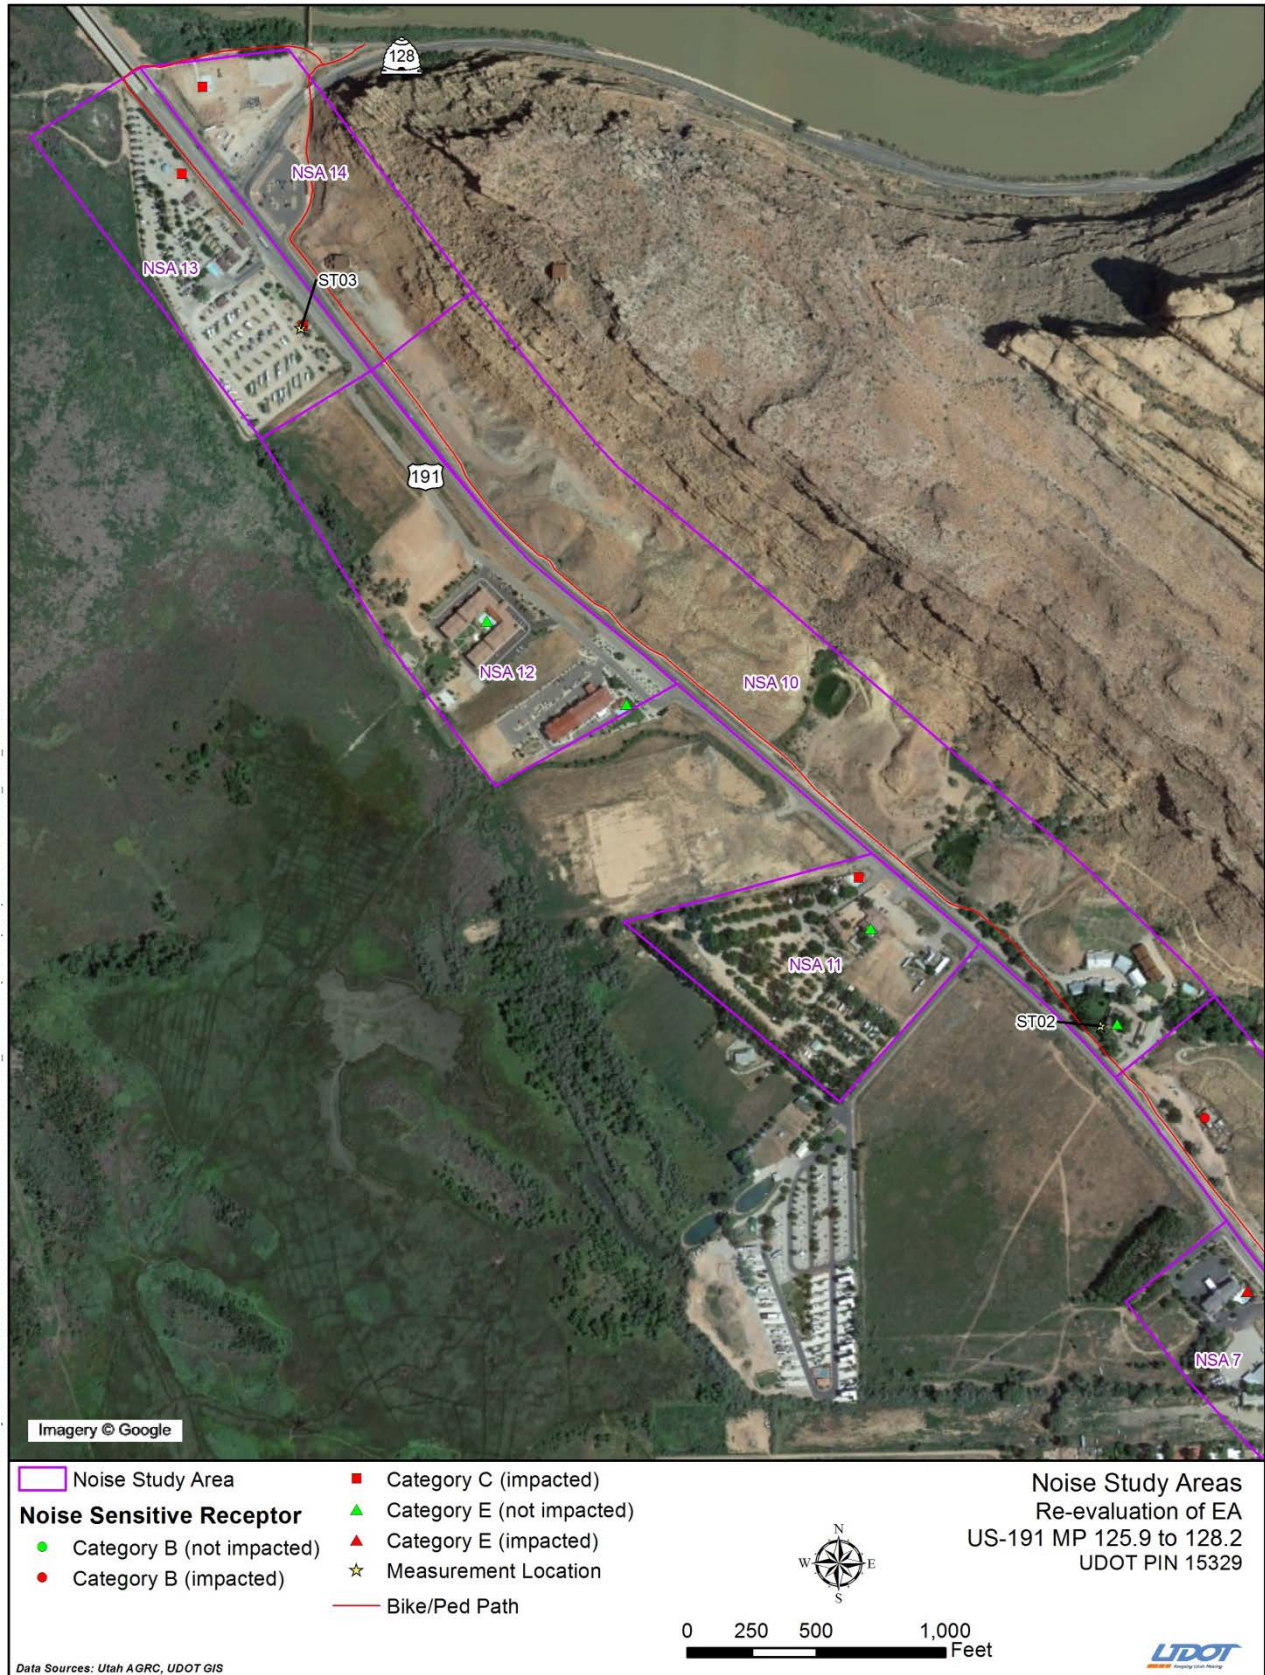
Figure 2a –Noise Study Areas (North)

NSA	Description	Activity Category
1	Receptors south of 400 North on the west side of the alignment (single family-homes, mobile home park, restaurant with outdoor seating)	B, E
2	Receptors east of the alignments between 400 North and Rosalie Court (single-family homes, hotels)	B, E
3	Receptors west of the alignment between 400 North and Emma Boulevard (multi-family residential, places of worship)	B, D
4	Receptors on the east side of the alignment from approximately Rosalie Court to Sunset Grill entrance (hotel)	E
5	Receptors west of the alignment between Emma Boulevard and North Mi Vida Drive (single-family homes)	B
6	Receptors west of the alignment between North Mi Vida Drive and Marcus Court (single-family homes)	B
7	Receptors west of the alignment between Marcus Court and the undeveloped lands adjacent to Motel 6 (single-family homes, hotel)	B, E
8	Receptors on the east side of the alignment from Sunset Grill entrance to approximately the 500 West intersection (hotel)	E

9	Receptors on the east side of the alignment from approximately the 500 West intersection to Arrowhead Lane (single-family home, bike path)	B, C
10	Receptors on the east side of the alignment from Arrowhead Lane to the entrance to the abandoned tram (hotel, bike path)	E, C
11	Receptors west of the alignment between the Portal RV Resort entrance and the Slick Rock Campground entrance (campground, restaurant with patio seating)	E
12	Receptors west of the alignment along Riverview Drive (hotels)	E
13	Receptors west of the alignment between the Riverview Drive intersection and the Colorado River (campground and bike path)	C
14	Receptors on the east side of the alignment from the entrance to the abandoned tram to the Colorado River (park and bike path)	C

Five representative noise measurements were conducted in the Study Area for noise model validation. These were conducted using a Larson Davis 820 Type 1 Sound Level Meter (SLM). See Figure 2 for noise measurement and prediction locations. Traffic counts were taken during the time periods of collection (observed traffic data is presented in Appendix C).

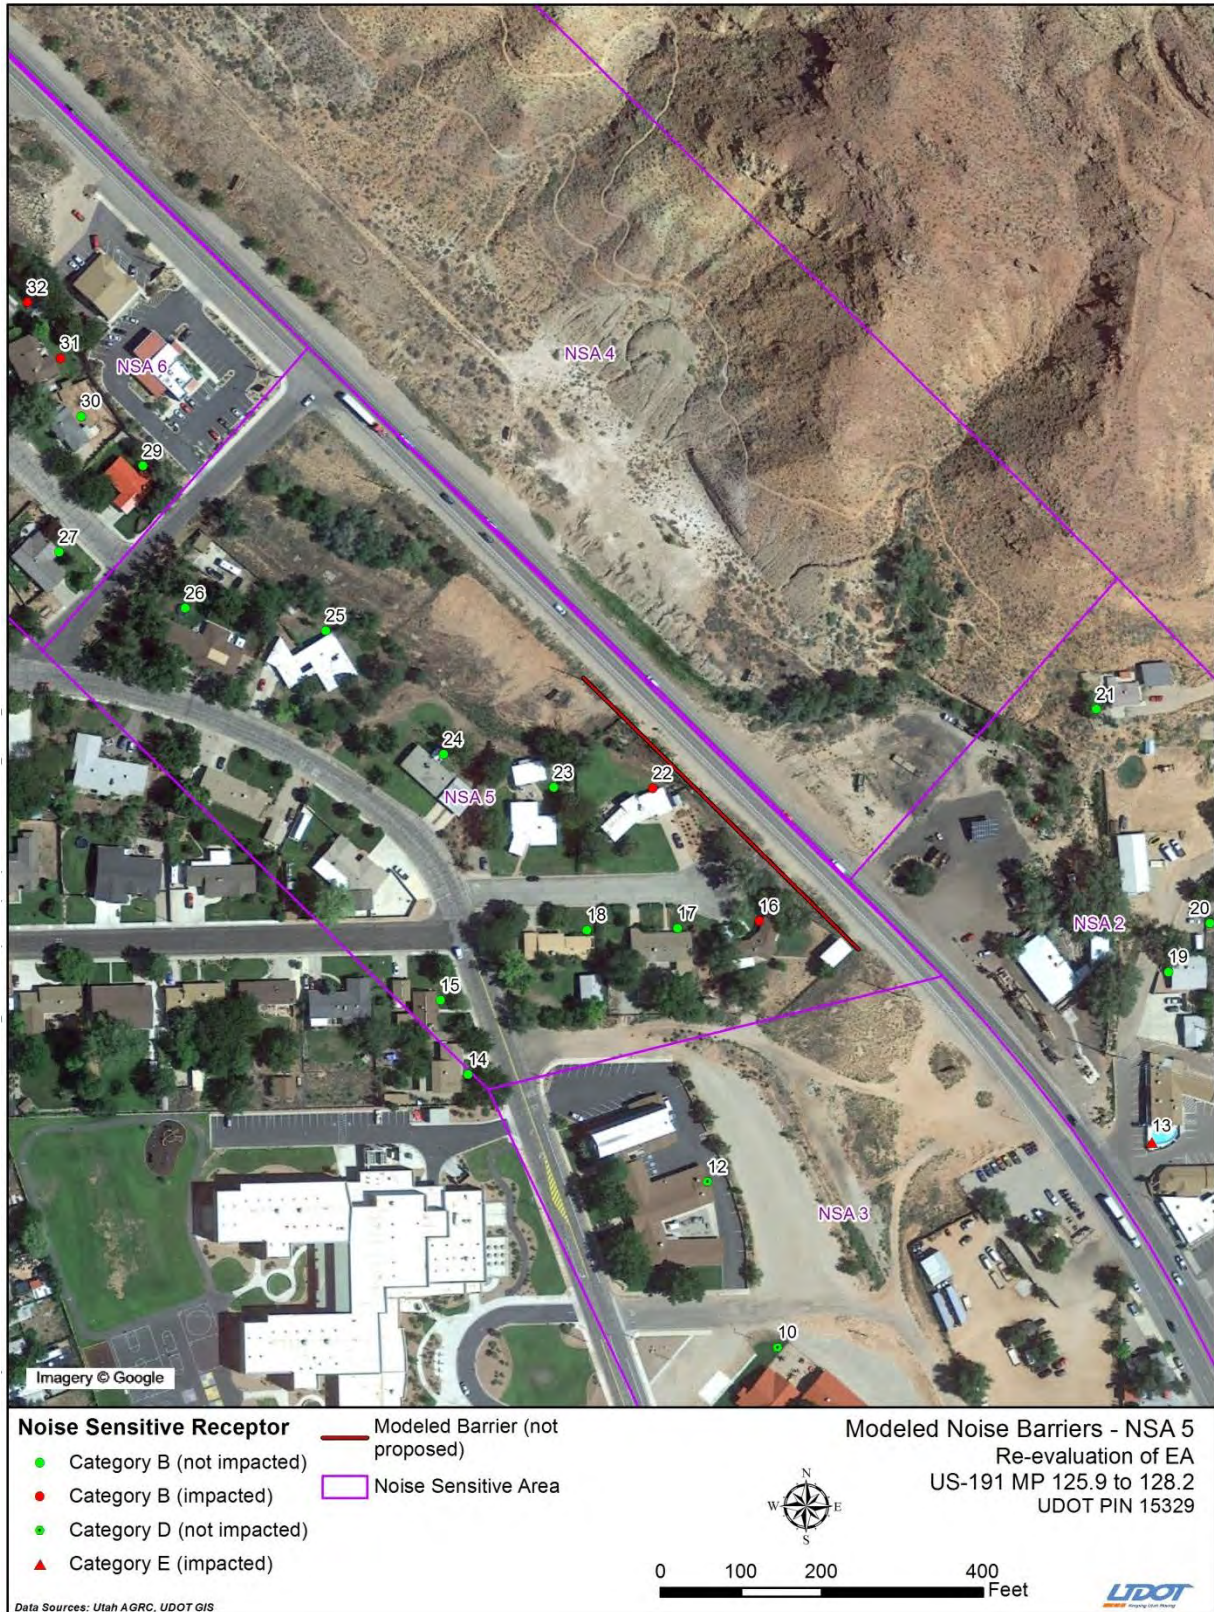
Figure 3 – Modeled Noise Wall Locations – NSA5

Table 7 – NSA5 Noise Wall Feasible and Reasonable Evaluation

Percent Front-Row 5.0 dBA Reduction	Percent Front-Row Design Goal	Benefitted Receptors	Total Estimated Cost	Cost per Benefitted Receiver	Conclusion
50%	50%	1	\$124,000	\$124,000	Not reasonable (exceeds cost per benefitted receptor allowance)

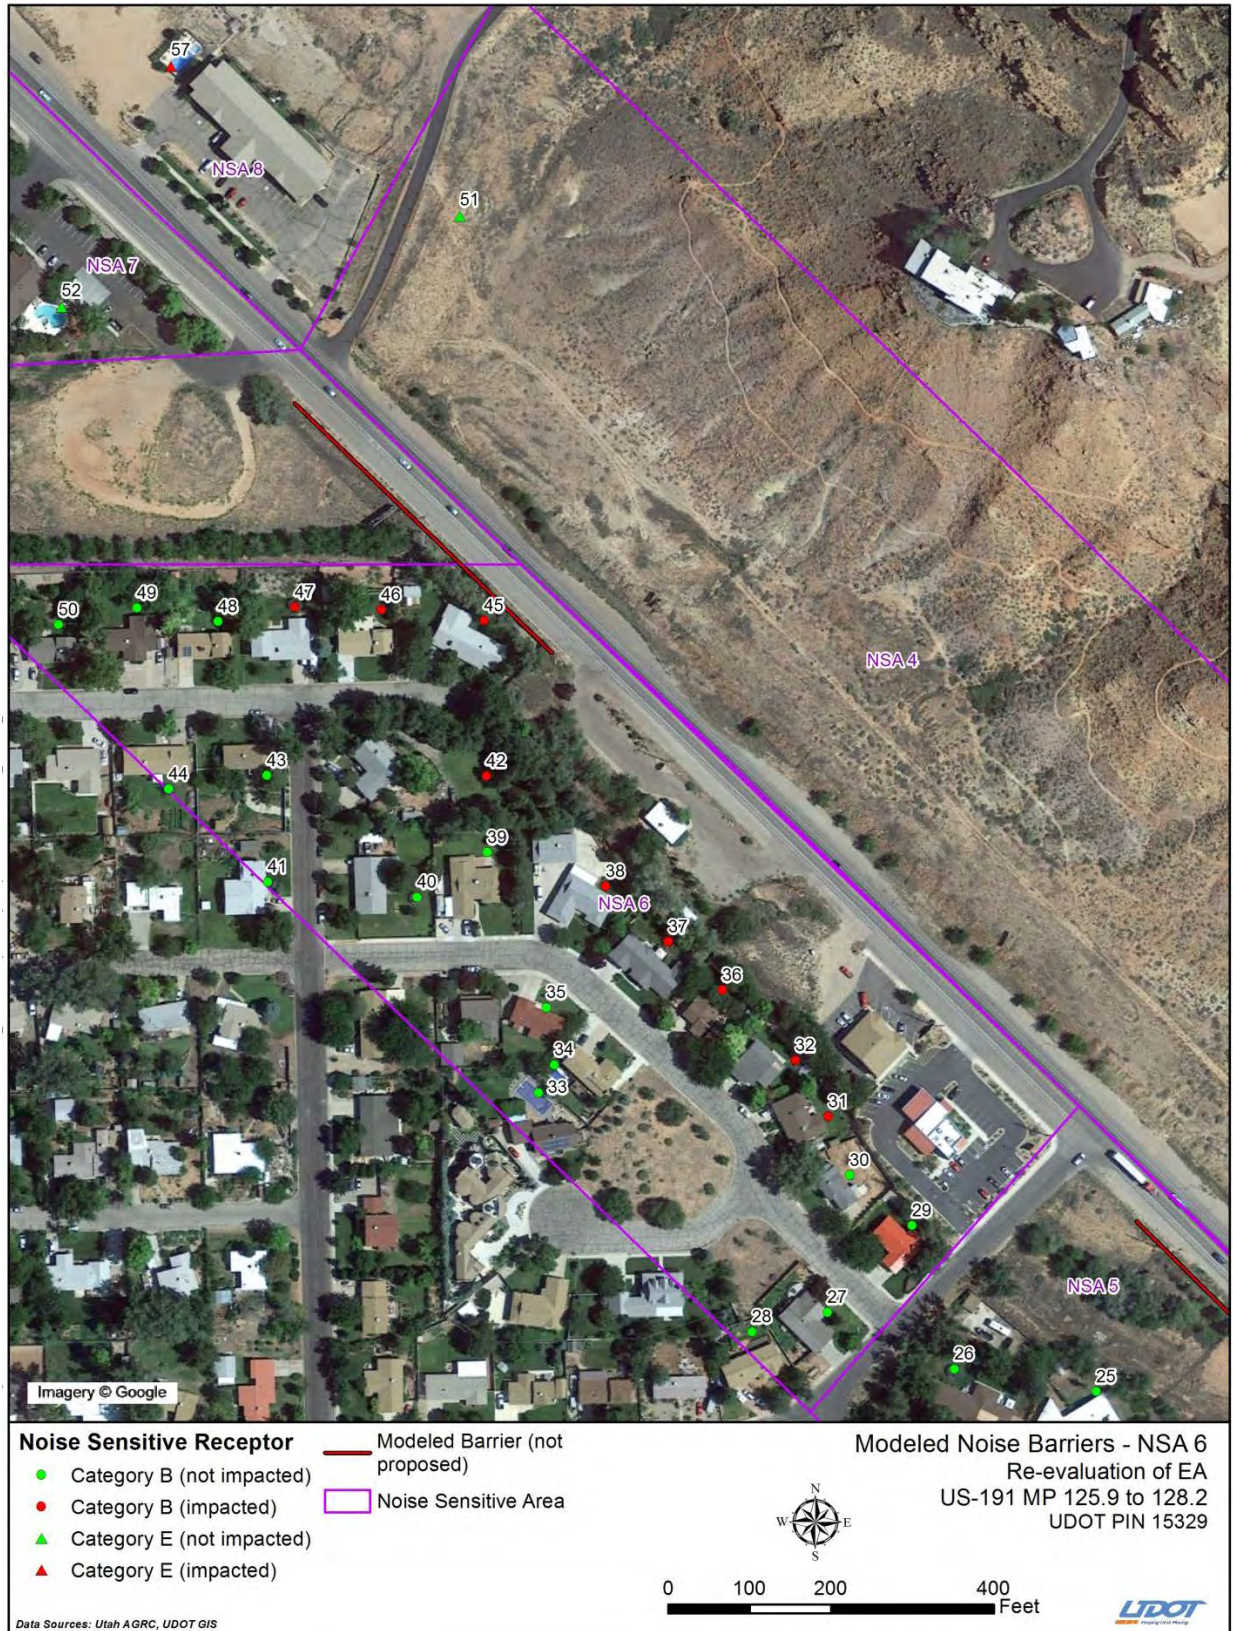
Figure 4 – Modeled Noise Wall Locations – NSA6

Table 9 – NSA6 Noise Wall Feasible and Reasonable Evaluation

Percent Front-Row 5.0 dBA Reduction	Percent Front-Row Design Goal	Benefitted Receptors	Total Estimated Cost	Cost per Benefitted Receptor	Conclusion
25%	25%	1	-	-	Not feasible (less than 50% of front-row receptors receive 5.0 dBA reduction)

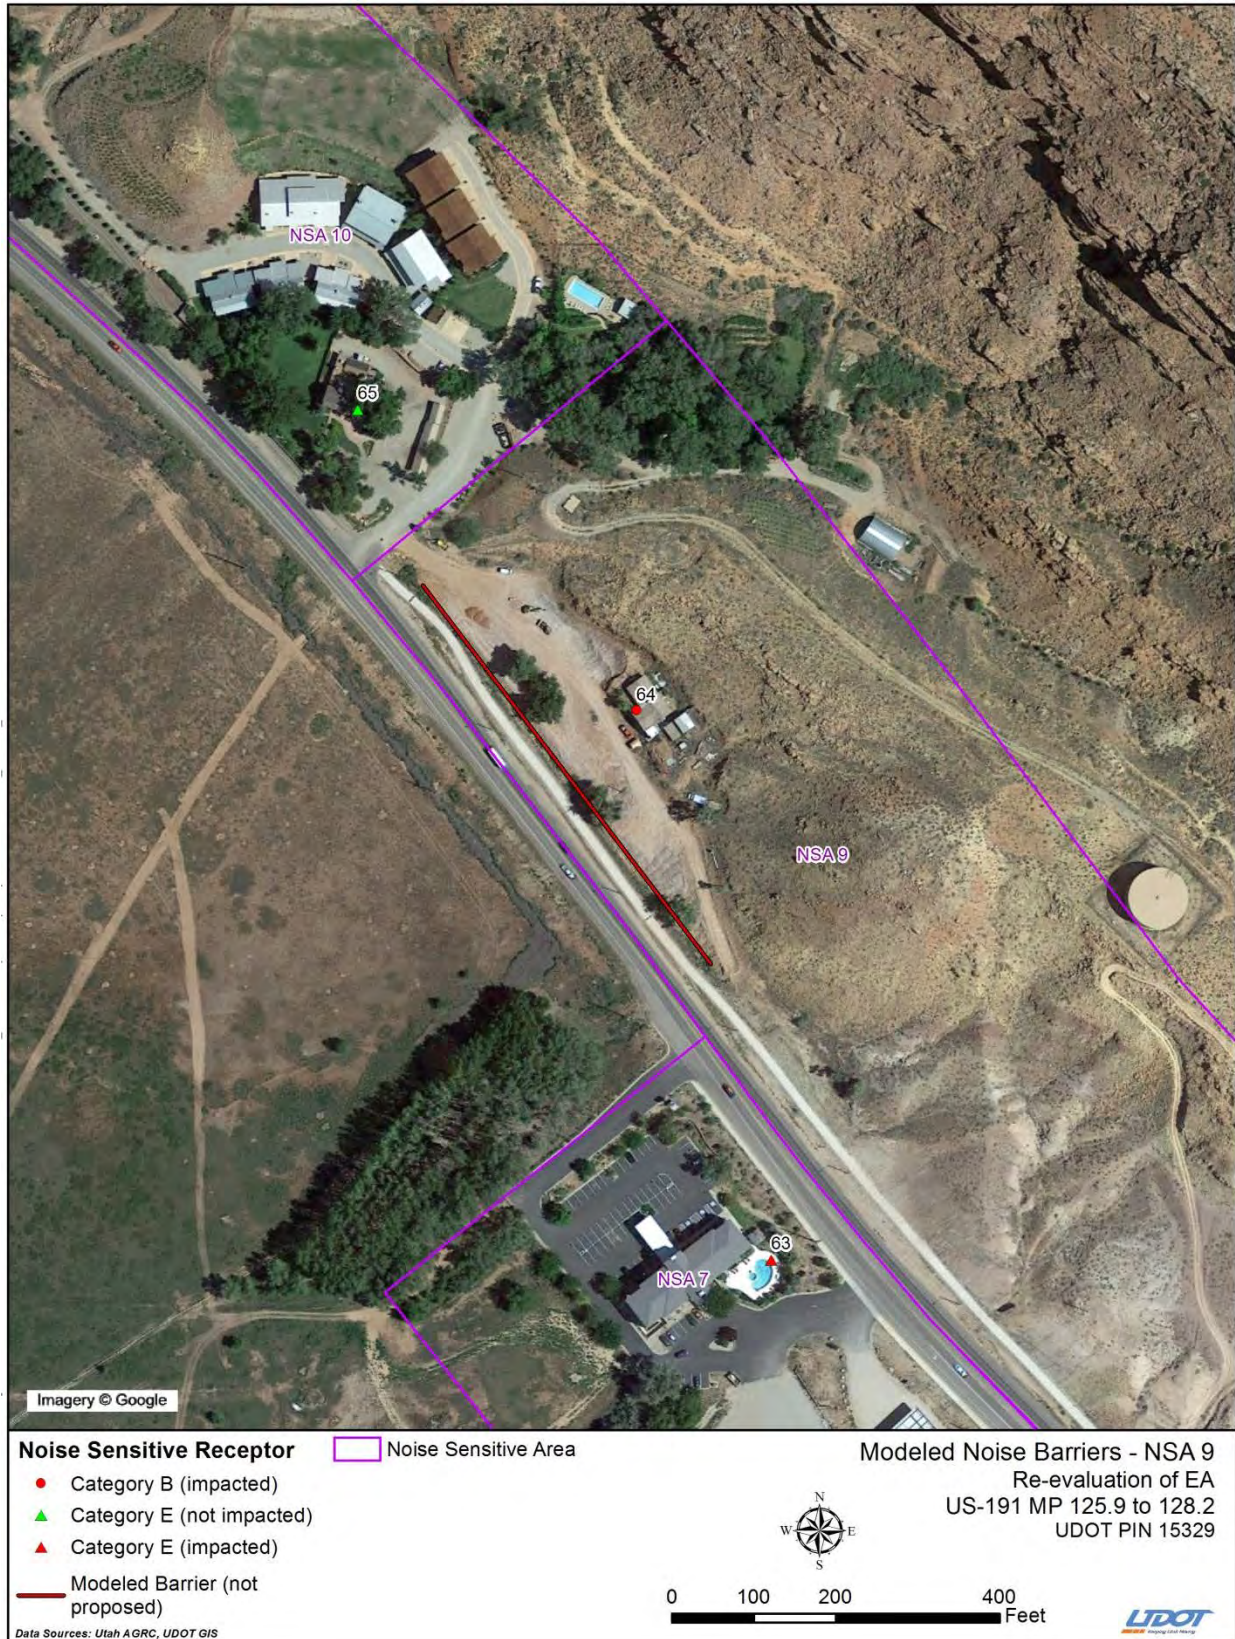
Figure 5 – Modeled Noise Wall Locations – NSA9

The only noise-sensitive land use in NSA 9 is receiver 64, which is the residence at 1050 North Main (Hwy 191). A noise wall is most effective when placed near either the source or the receiver. In this area, the bicycle/pedestrian path is adjacent to the proposed back of curb. A noise wall was modeled on the ROW line which is 30 feet from the proposed back of curb (see Figure 5). A noise wall with segment heights varying between 14 feet and 20 feet – average height of 19.6 – would provide a 7.0 dBA reduction for receiver 64 (see Table 10). Applying the \$20 unit cost, this noise wall would cost \$220,036 to construct (see Table 11). This exceeds the \$30,000 per benefitted receptor maximum and the noise wall is not proposed for this project.

Table 11 – NSA9 Noise Wall Feasible and Reasonable Evaluation

Percent Front-Row 5.0 dBA Reduction	Percent Front-Row Design Goal	Benefitted Receptors	Total Estimated Cost	Cost per Benefitted Receptor	Conclusion
100%	100%	1	\$220,036	\$220,036	Not reasonable (exceeds cost per benefitted receptor allowance)

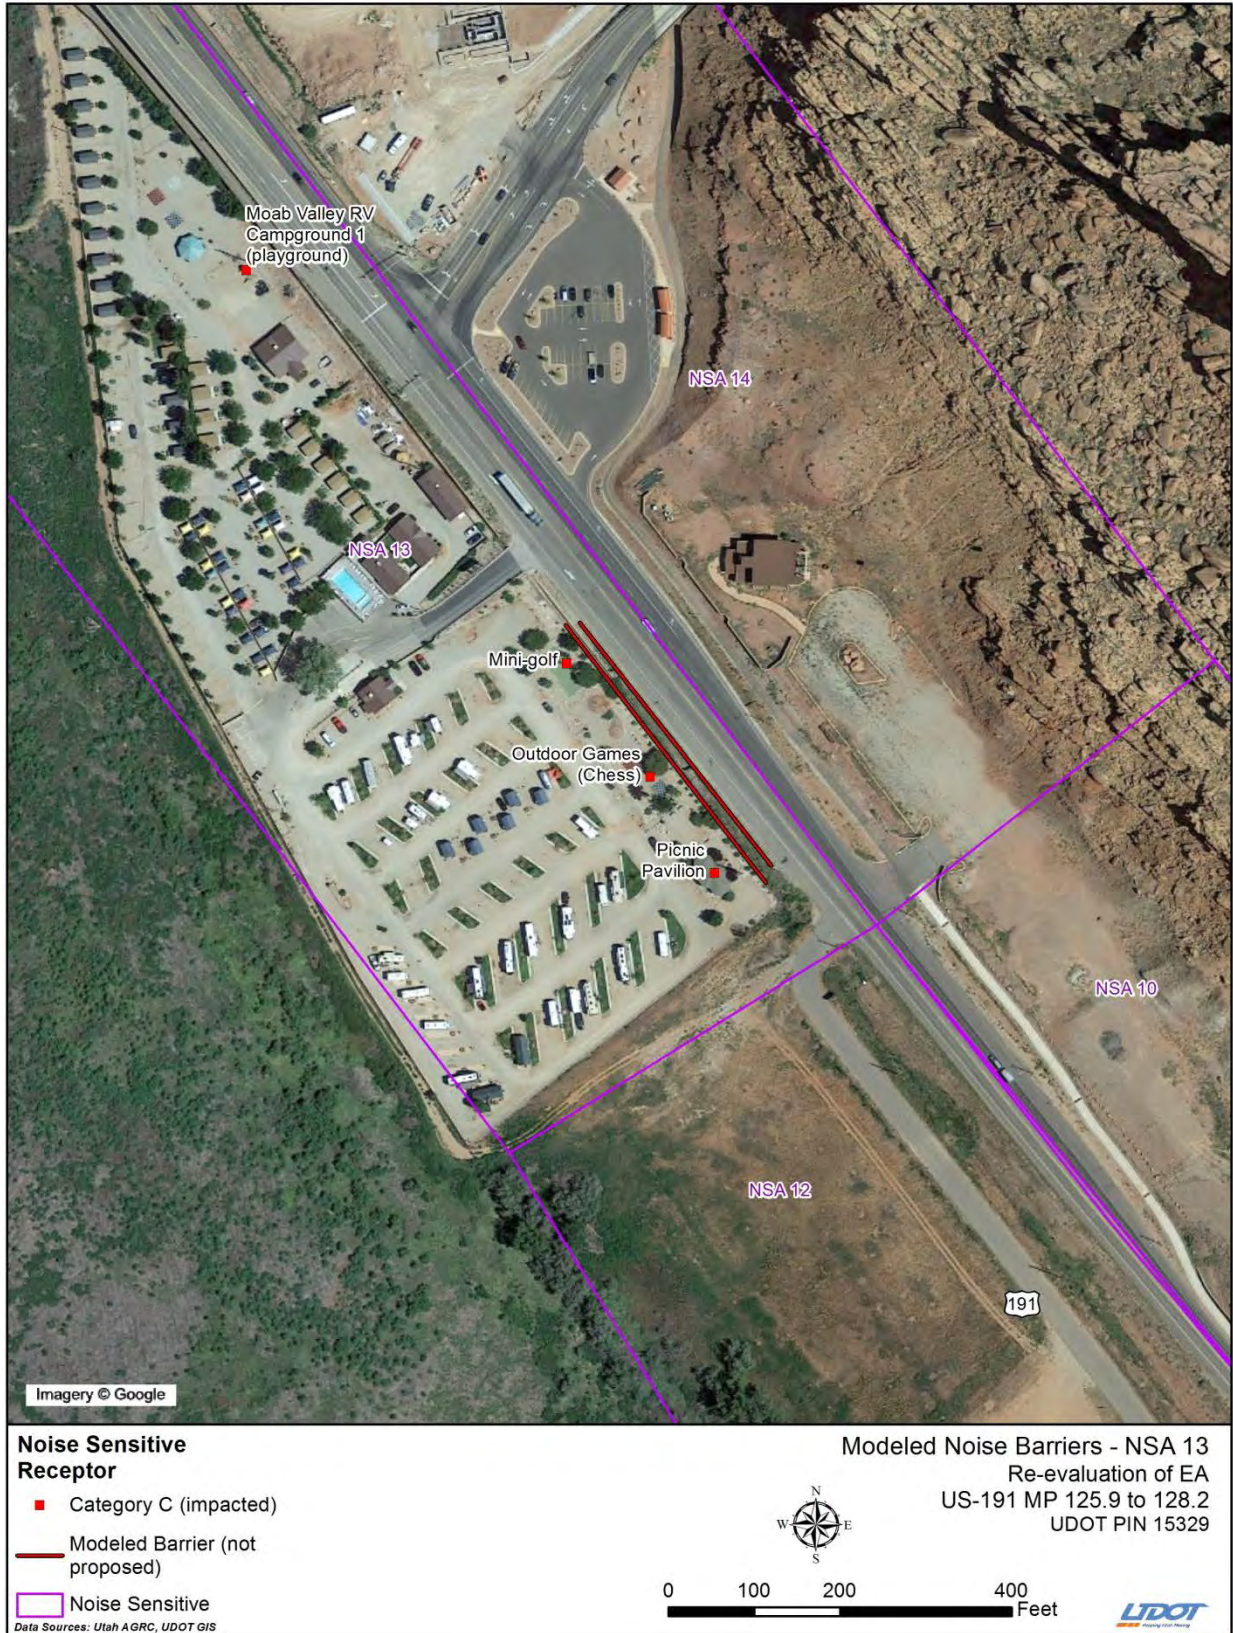
Figure 6 – Modeled Noise Wall Locations – NSA13

South of the entrance, the areas of outdoor human use are a mini-golf area, a game area and a picnic pavilion. Additionally, the RV sites have grassy areas with picnic tables. While the campground is a single land use, the game areas were included in the noise model for the purposes of analyzing mitigation. Two noise walls were modeled for this south portion of the campground: one at the top of slope to be nearest the source, and one on the ROW line on the toe of slope to be nearest the receiver. Both were modeled from approximately the Frontage Road intersection to the entrance to Moab Valley RV Resort and Campground (see Figure 6).

The noise wall at the top of slope would be 14 feet from the proposed back of curb. A noise wall 14 feet tall at the top of slope would provide a 7.2 dBA reduction in noise levels for the game area (see Table 12). This wall does not provide a 5.0 dBA reduction for any of the other modeled receptors and is therefore not acoustically feasible (see Table 13). This noise wall is not proposed for this project.

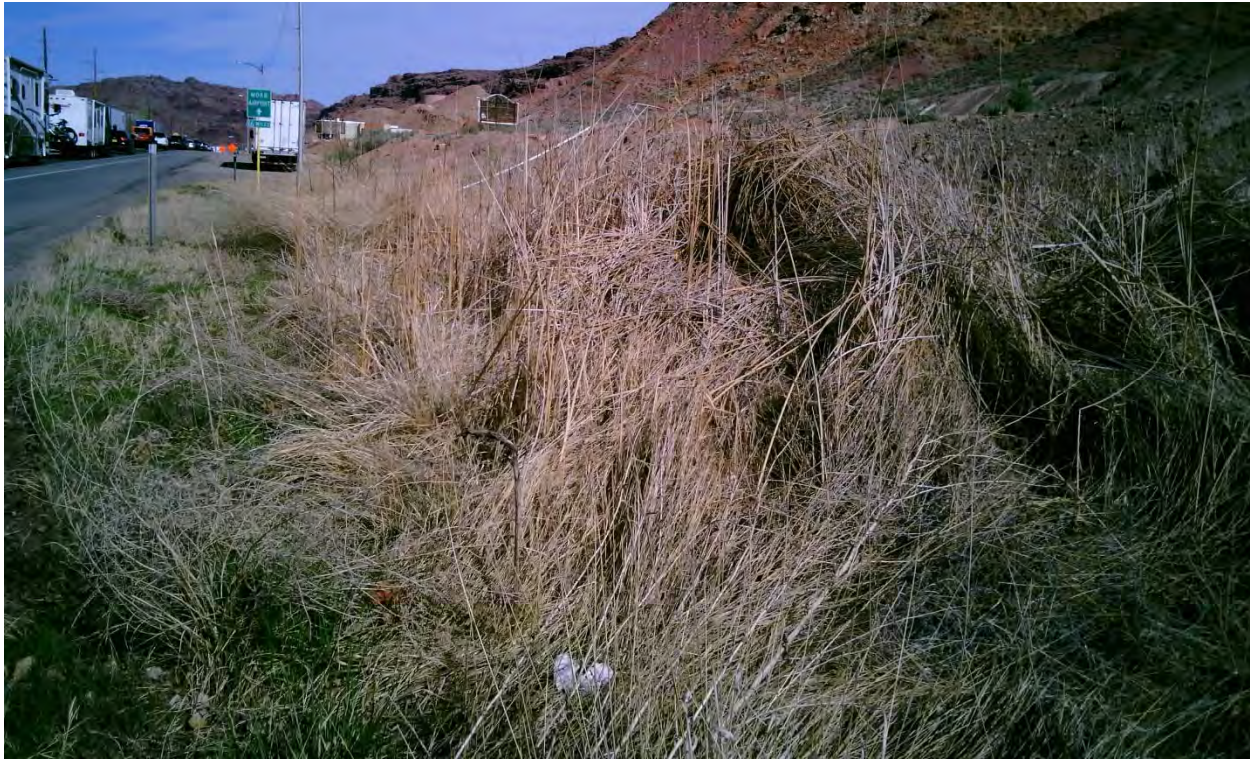
Figure 1 – Typical Cattail Dominated Wetland (W8)

Four perennial waters cross the ROW within this project area. The source of these waters are hillside springs to the east of the ROW. Cattail (*Typha*) dominated wetlands have developed within three of these features. Figure 1 shows a typical cattail wetland (W8). One small wetland area (W4) is grass and sedge grown in at a road culvert outflow on the west side of the highway. The flow backs up into the ROW due to a stock watering trough (Figure 2).

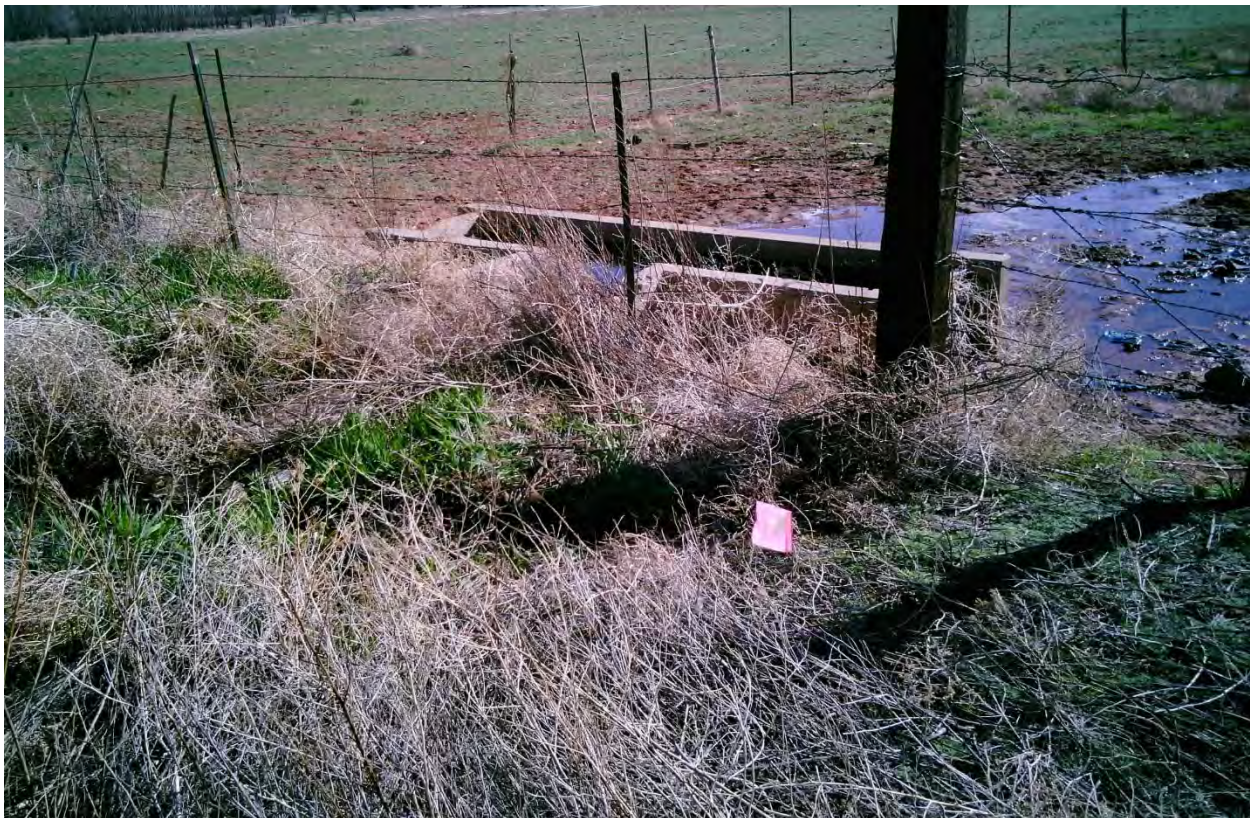
Figure 2 – Wetland at Culvert Near Stock Watering Trough (W4)

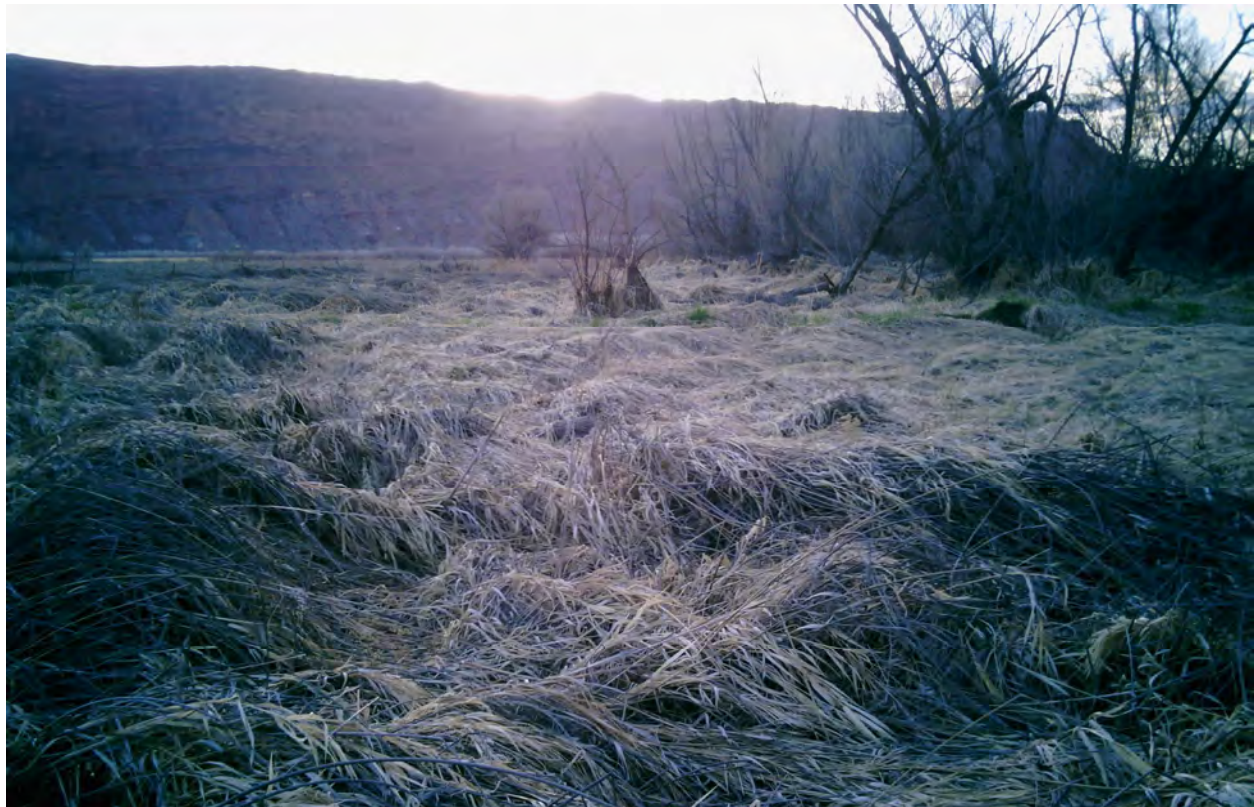
Figure 4 – Wetland Showing Hydrophytic Vegetation (facing west from data point 8C)

Two wetland areas (W5, W6) occur to the west of the project corridor. It is assumed that these may have historically been one larger wetland complex that has been divided by recent residential development and roads/driveways but are still connected via culverts, channels, and high ground water. Figure 4, taken from an adjoining property, shows the presence of hydrophytic vegetation. W6 is dominated by Reed Grass (*Phalaris*) which is present due to high groundwater providing saturated soil near the ground surface (Figure 5).

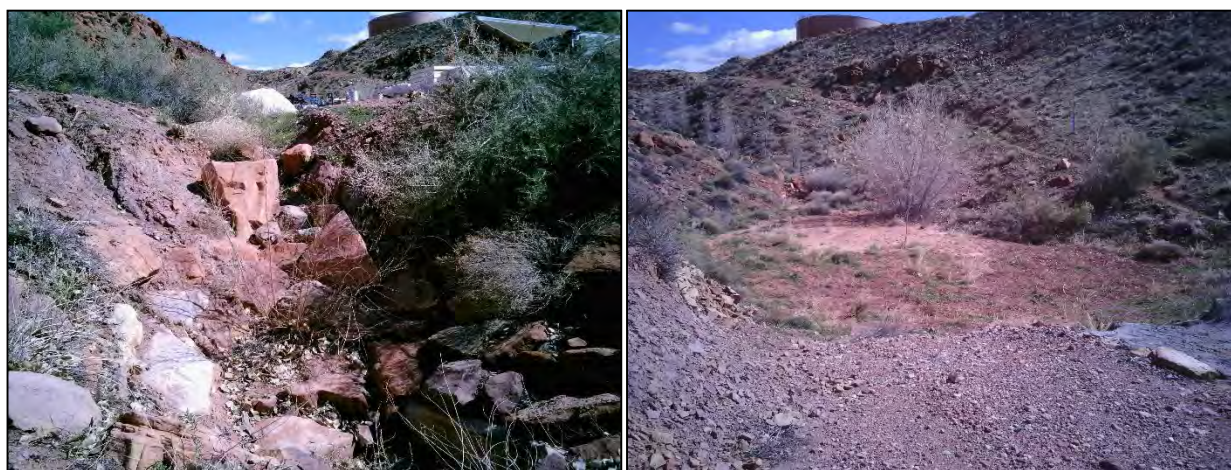
Figure 6 – Dry Detention Basin

Above Detention Basin (not mapped as a wash) Detention Basin (bare soil & upland veg.)

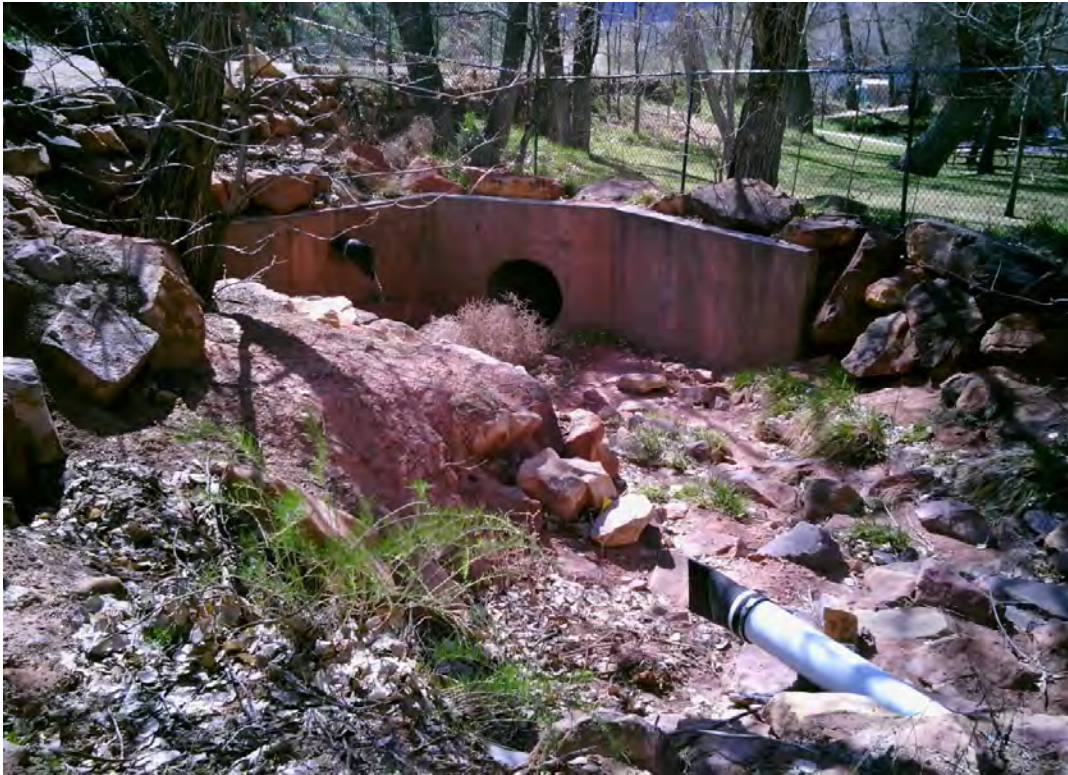
The photograph below shows sediment deposition as well as a substantial structure constructed to handle heavy runoff. This is located at the confluence of two washes (DW2 & DW3). The wash containing the detention basin is by far the smaller drainage area. The other wash (DW1) is shown in Figure 8.

Figure 7 – Channel Mapped as Dry Wash Below Detention Basin

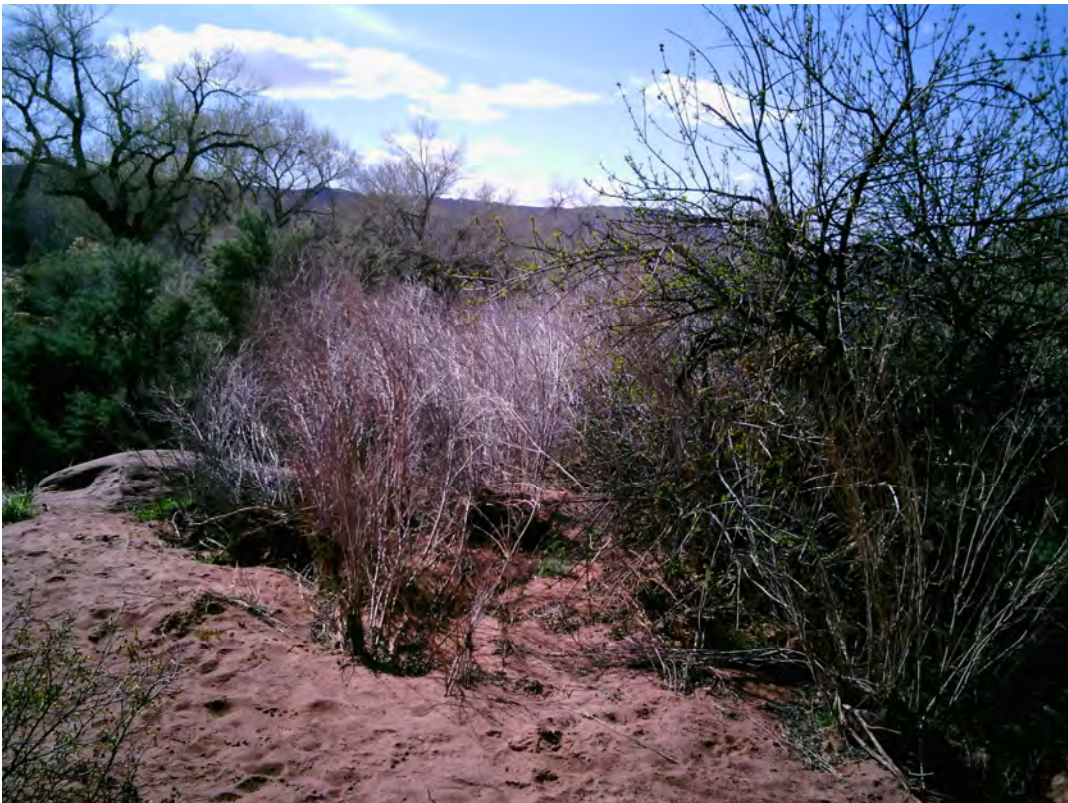
Figure 8 – Dry Wash with Willows (mapped as DW1)

Sometime in the past sediment was trapped in this wash long enough for willows to become well established. A new channel has scoured through the sediment causing dryer conditions in the sediment but the willows persist. Data Points 4 and 4B are at this location.

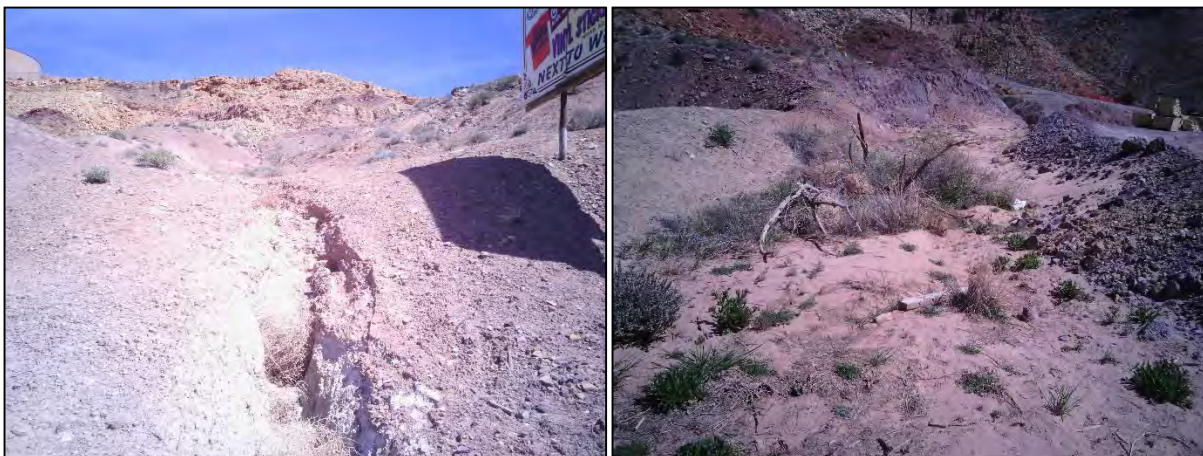
Figure 9 – Typical Features Not Mapped as Washes

Steep Unconsolidated Soil Erosion

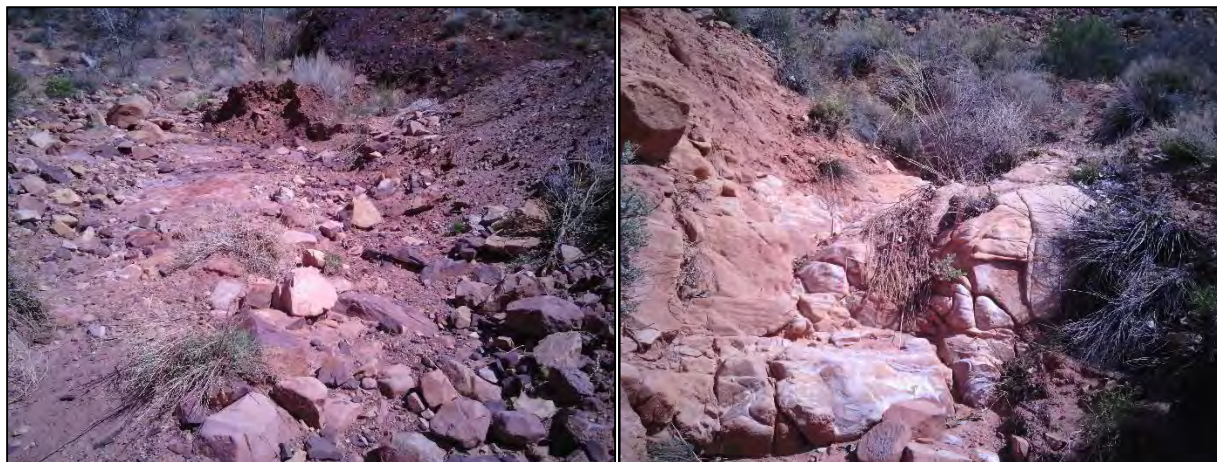
Figure 10 – Features Mapped as Dry Washes

Vegetation is bent downstream, patches of sediment & channels continue downstream.

The wash on the left (wash DW4) has a small patch of water and wetland vegetation just above the project area. There are several poorly defined segments of wash or erosion features in this area and this one has recently been diked on the left side of it which is one reason it was mapped as the current channel. On the right, wash DW5 has a well developed channel evident in the aerial photograph. However, debris has changed the route of flow and several small erosion pathways have formed south of the old channel. These end at a flat shelf area with no evidence of flow downslope.

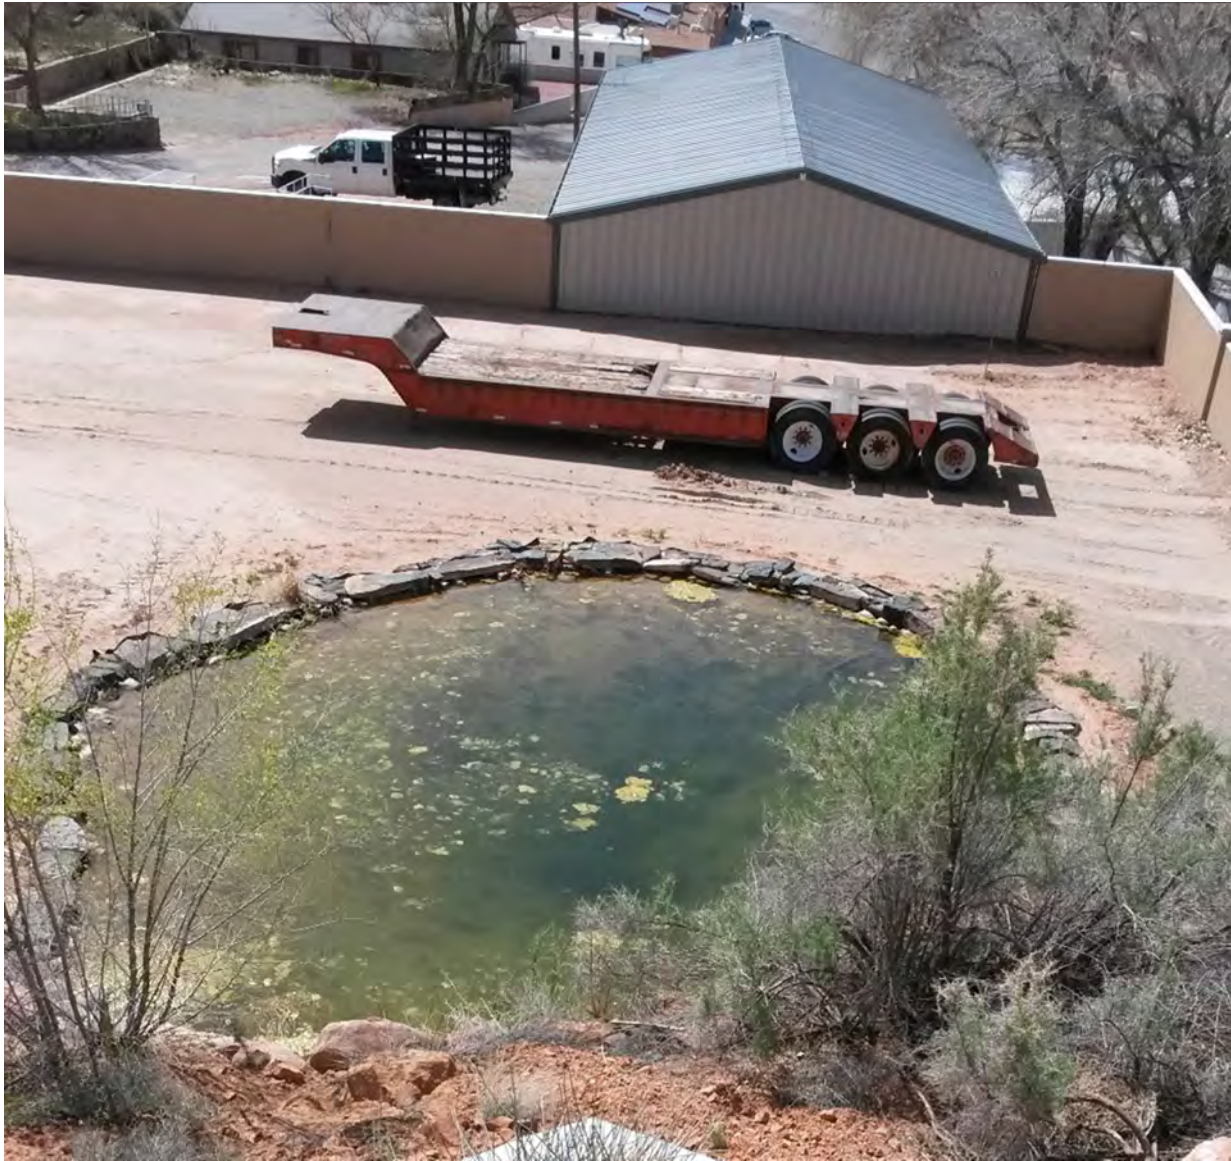
Figure 11 – Spring-fed Ornamental Pond

Channel segments PC4 through PC6 are all one feature connected by culverts. This channel is generally 2-5 feet wide and flows from a spring-fed ornamental pond (Figure 11). The pond outflow is piped for a distance of about 70 feet and discharges approximately 15 feet above the ground surface (Figure 12).

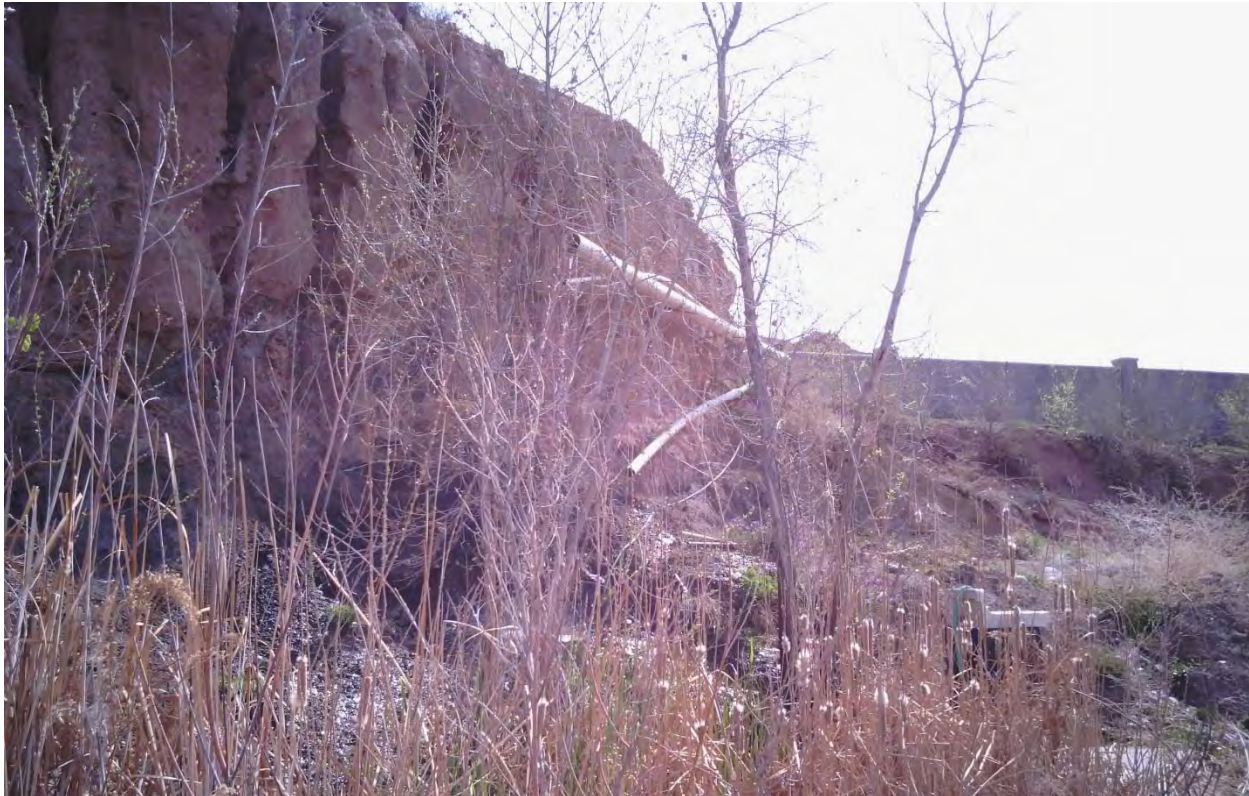
Figure 12 – Discharge Pipe from Ornamental Pond

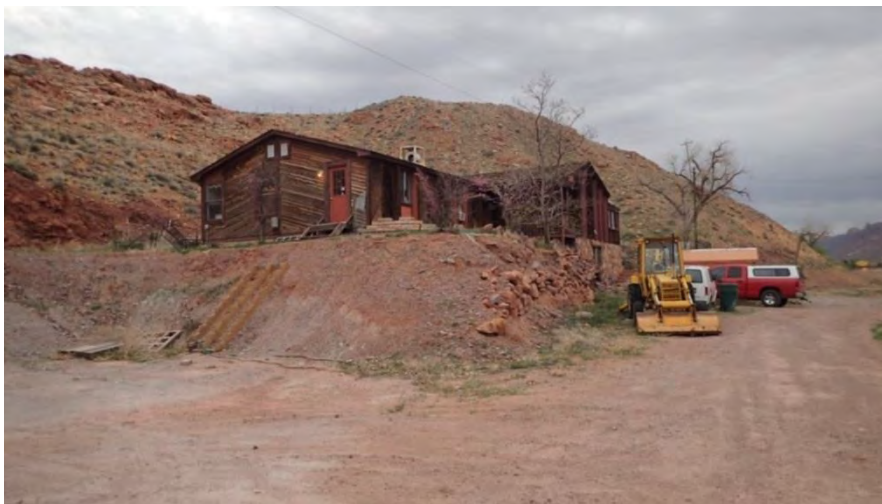
**Figure 5-1. View looking north at northern recorded segment of historic Moab-Thompson Wagon Road (42GR2813).
Rock wall now used as retaining wall for residence at 1050 N. Main.**
