Subject: UDOT Project Number F-0191(152)126, US-191, North Moab to Colorado River Bridge,
Grand County, Utah (PIN 15329)
Environmental Assessment Re-evaluation

A Final Environmental Assessment (EA) and Programmatic Section 4(f) Evaluation for the US-191 Colorado Bridge For Bridge/Roadway Reconstruction and Widening on US-191, from 400 North in Moab City to SR-279 (Potash Road), Grand County, was completed (2007) and approved through the issuance of a Finding of No Significant Impact (FONSI) (May 25, 2007) from the Federal Highway Administration (FHWA). Design modifications for the current phase between State Route 128 (SR-128) and 400 North in Moab, Grand County were not included in the 2007 EA and are the subject of this EA Re-evaluation. These improvements include a new stormwater collection system, three sedimentation basins, a vegetated water quality swale, a sedimentation dropout channel, and several new outfalls.

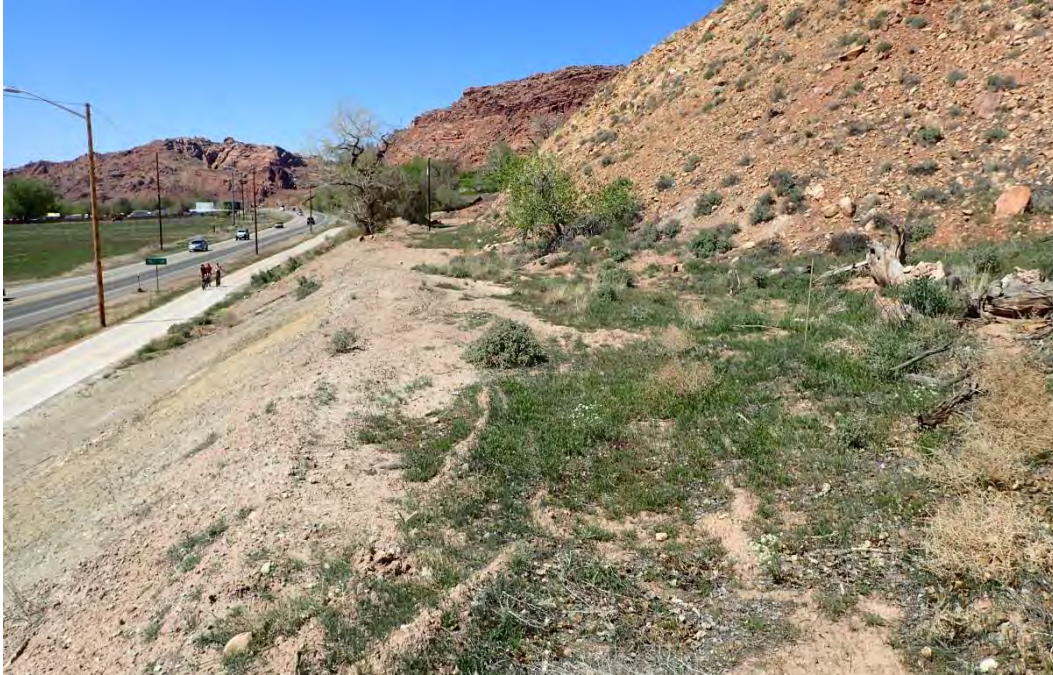
Figure 5-2. View of southern recorded segment of historic Moab-Thompson Wagon Road (42GR2813), looking north. Site destroyed by construction of bike path.

This site is described as several segments of the historic Moab-Thompson wagon road, which was in use from 1883 to 1919 when it was replaced by a federally funded highway. It was originally recorded in 2002 by Sagebrush Archaeological Consultants (Weymouth 1998) and re-recorded by Montgomery Archaeological Consultants in 2005 (Montgomery 2005; Whitfield et al. 2006a:15) and 2007 (Montgomery 2007). The form was updated in 2009 (Larmore 2009) and 2011 (Bennett 2011). Two segments of the historic wagon road in Moab were previously recorded in the APE and were described as narrow, unpaved segments on the east side of US-191. The recorded northern segment is described as a stacked sandstone rock retaining wall (Feature A on the 2005 recording form) that ranges in height from 3 to 10 feet and presently serves as a driveway to the residence located at 1050 N. Main (**Figure 5-1**). The retaining wall is most likely associated with the residence rather than the historic wagon road, and the access road to the residence probably eliminated the wagon road. The southern segment was reported in 2011 as having been destroyed by construction of a nearby bike/pedestrian path. Other than a level area at this location, no evidence of a historic road was visible in 2018 (**Figure 5-2**). Near the northern end of the APE, a short section of rock wall that may be part of the historic wagon road was documented during the present survey (**Figure 5-3**). This feature is approximately 30 feet long, 12 inches wide, and curves slightly to the east. It is approximately 4 feet tall, with 8 to 9 courses of local sandstone. The wall has collapsed in the center. This wall may have been built for another purpose, but based on historical maps, the wall is in the correct location to be associated with the Moab-Thompson wagon road.

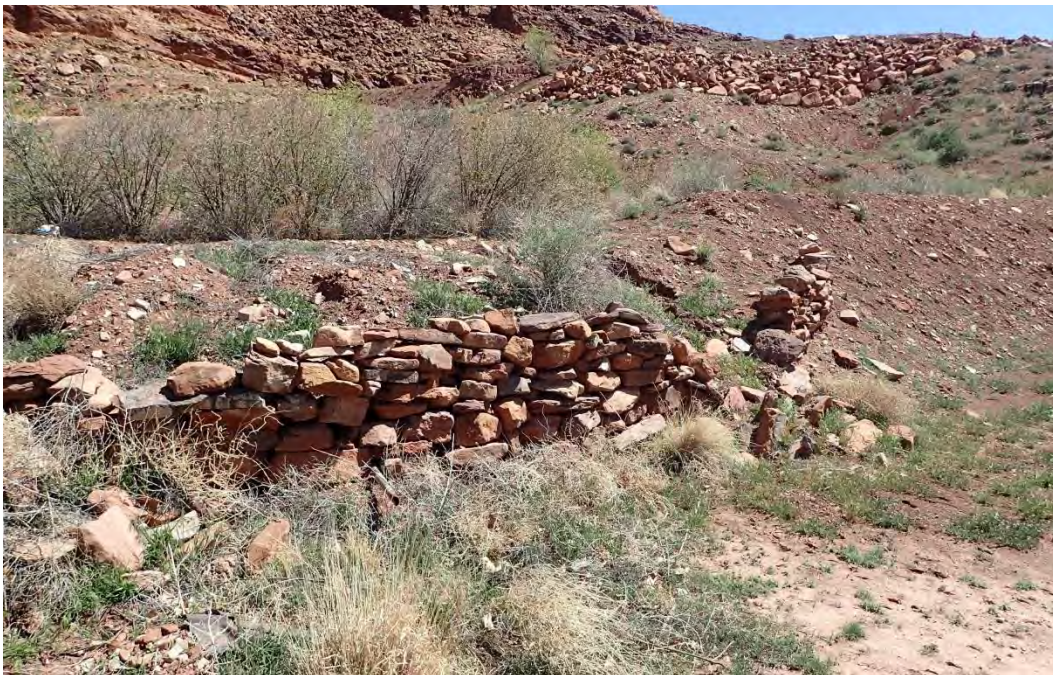
Figure 5-3. Segment of rock wall that may be associated with historic Moab-Thompson Wagon Road (42GR2813).

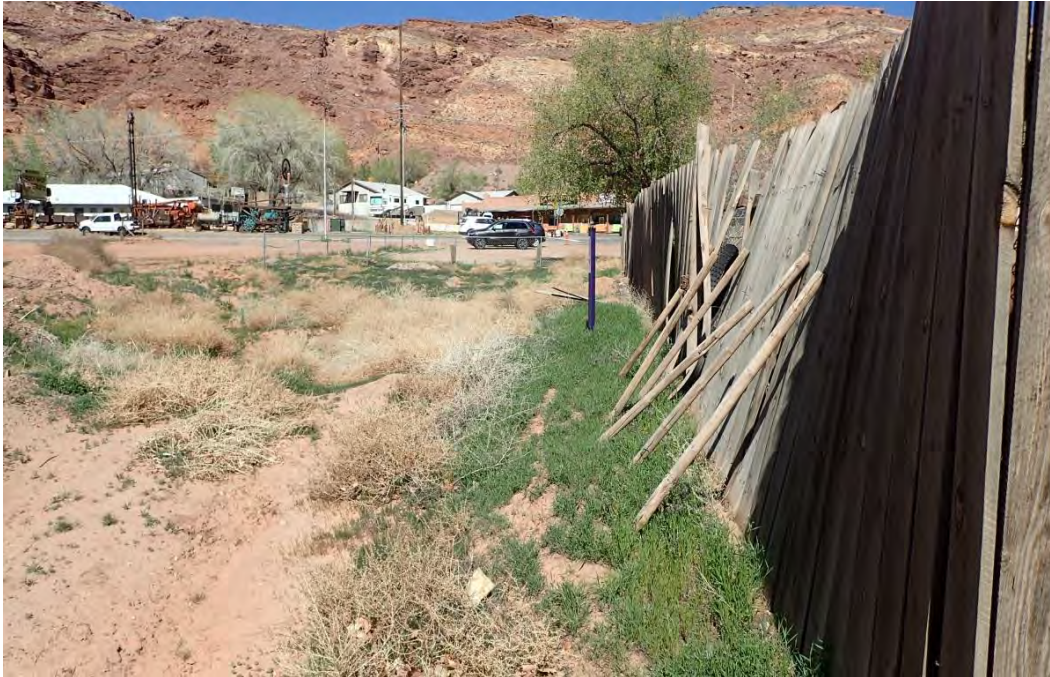
Figure 5-4. Site of historic ditch (42GR3622); the ditch is no longer visible.

This site is a historic ditch. It was documented in 2005 as a shallow, earthen ditch approximately 50 feet long, 3.3 feet wide, and 1.5 feet deep (Whitfield et al. 2006a:16-17). It was overgrown with weeds and grass and it contained no water. No artifacts were found in association with the ditch. Recent disturbance in the area has removed any evidence of the ditch (**Figure 5-4**).

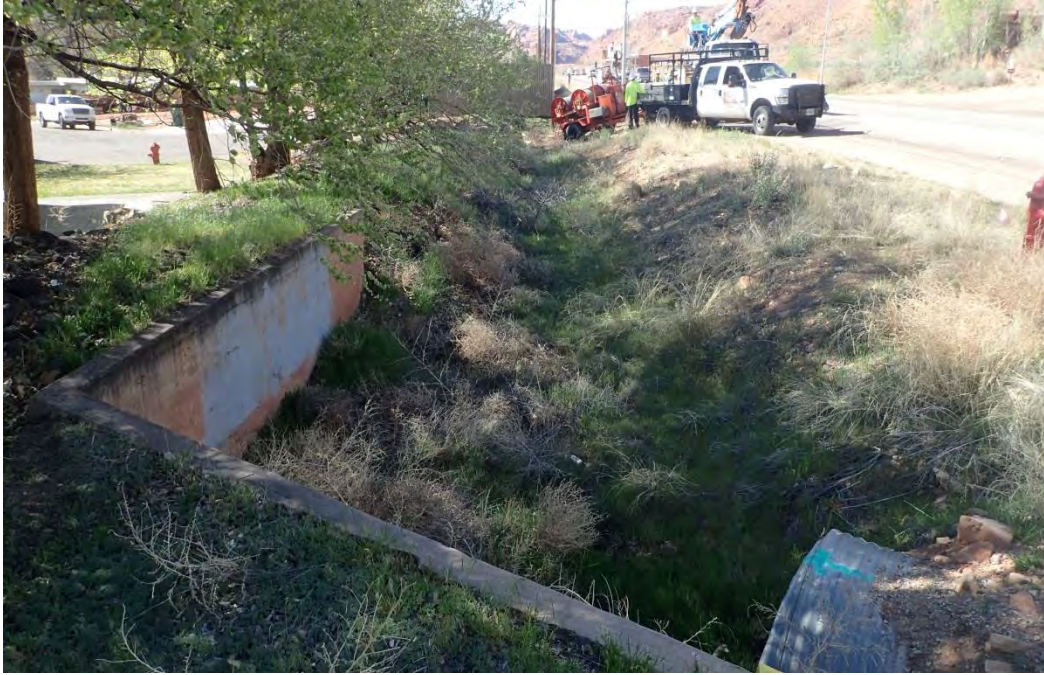
Figure 5-5. Feature B, concrete wall and culvert, for historic ditch (42GR3623).

This site was documented in 2005 as two segments of a historic earthen ditch, which originates at a natural spring in Stewart Canyon on the east side of the Moab Valley (Whitfield et al. 2006a:17). The first segment runs along the northern edge of the parking lot for Lin Ottinger's Rock Shop, continues northwest in a shallow ditch on the east side of the highway, crosses underneath the highway, and continues northwest on the west side of the highway. This segment of the ditch appears on a ca. 1930s UDOT as-built sheet. The second segment of the ditch begins in a culvert (Feature A) north of the rock shop, passes underneath the highway in a large (4-foot diameter) corrugated metal pipe, and empties into a channel on the west side of the highway. A concrete wall, with two wings set at an obtuse angle (Feature B), directs the water coming out of the metal pipe into the channel (**Figure 5-5**). This wall probably dates to the 1950s. This segment continues northwest along the outer edge of a residential neighborhood to join the first segment between the highway and a parking lot. The ditch segments are weedy and overgrown, but their size and alignments match the original 2005 documentation.

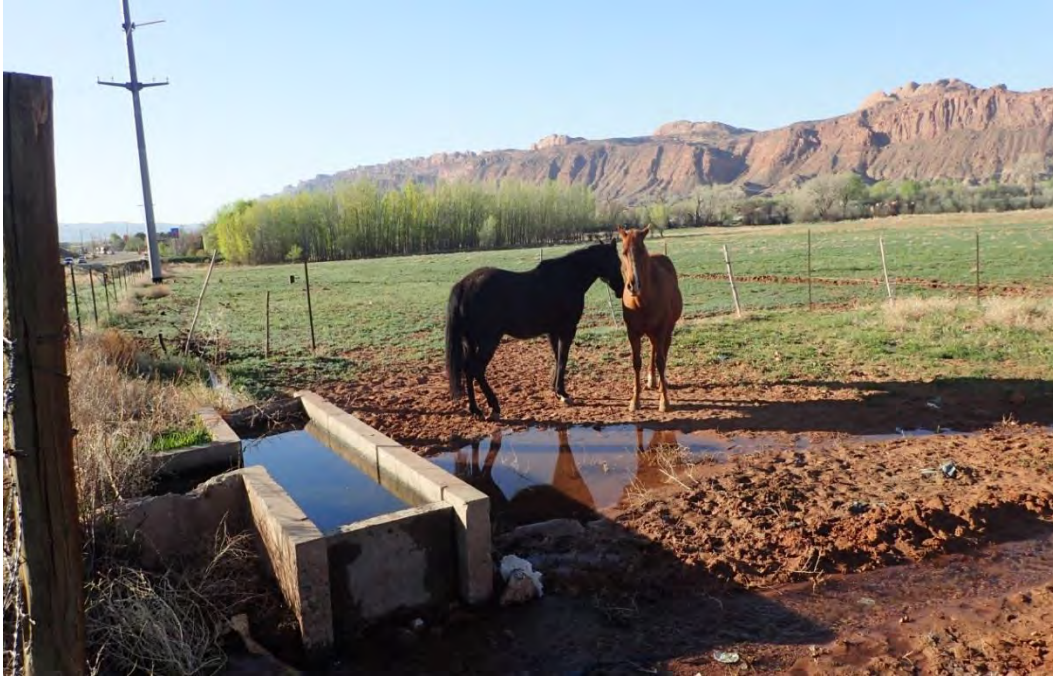
Figure 5-6. View of the headgate (Feature A) of the historic irrigation ditch (42GR3625), looking south. The ditch to the south (running just west of powerline) has been replaced by 10-inch PVC pipe. Note hand-dug feeder laterals in agricultural field west of the enclosure.

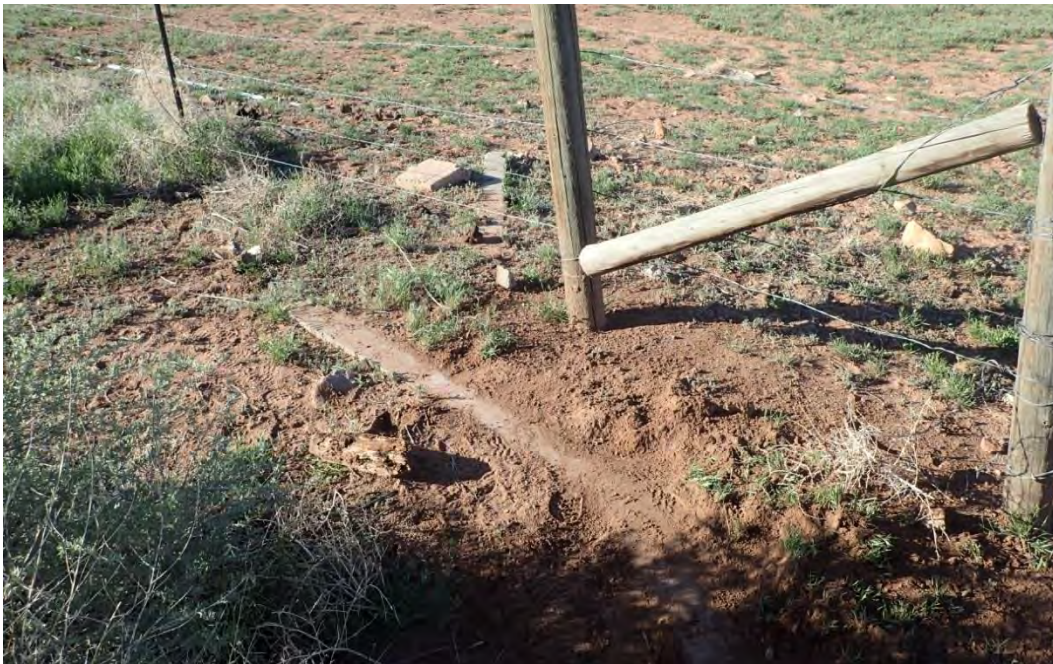
Figure 5-7. Previously unrecorded concrete features associated with the historic irrigation ditch (42GR3625).

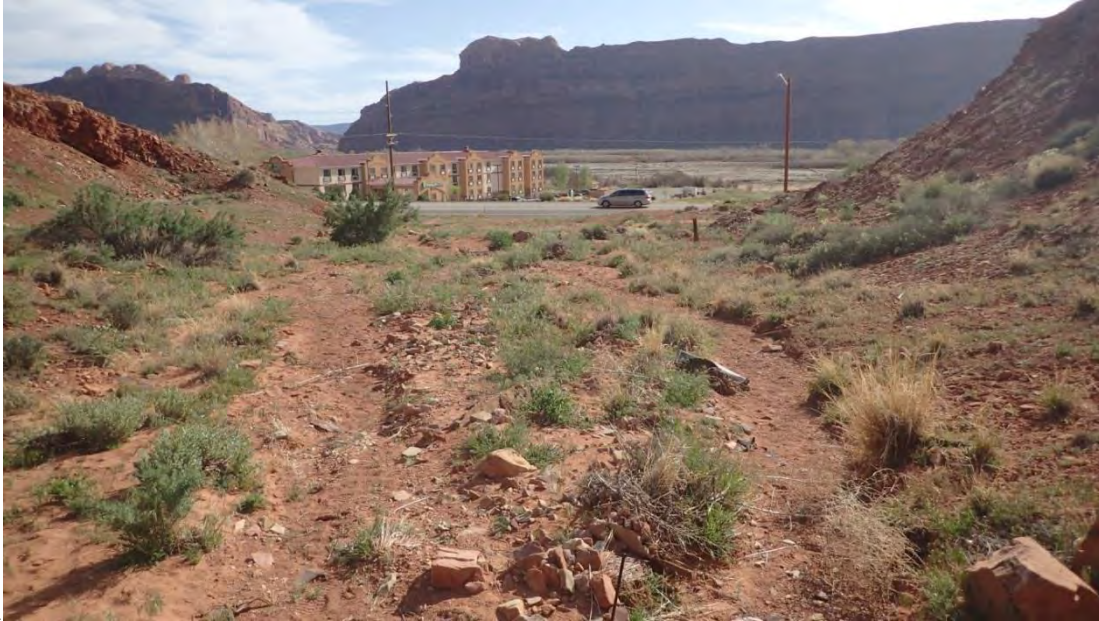
**Figure 5-11. Overview of 42GR3629, historic debris scatter, looking west.
Note charred wooden post at right center.**

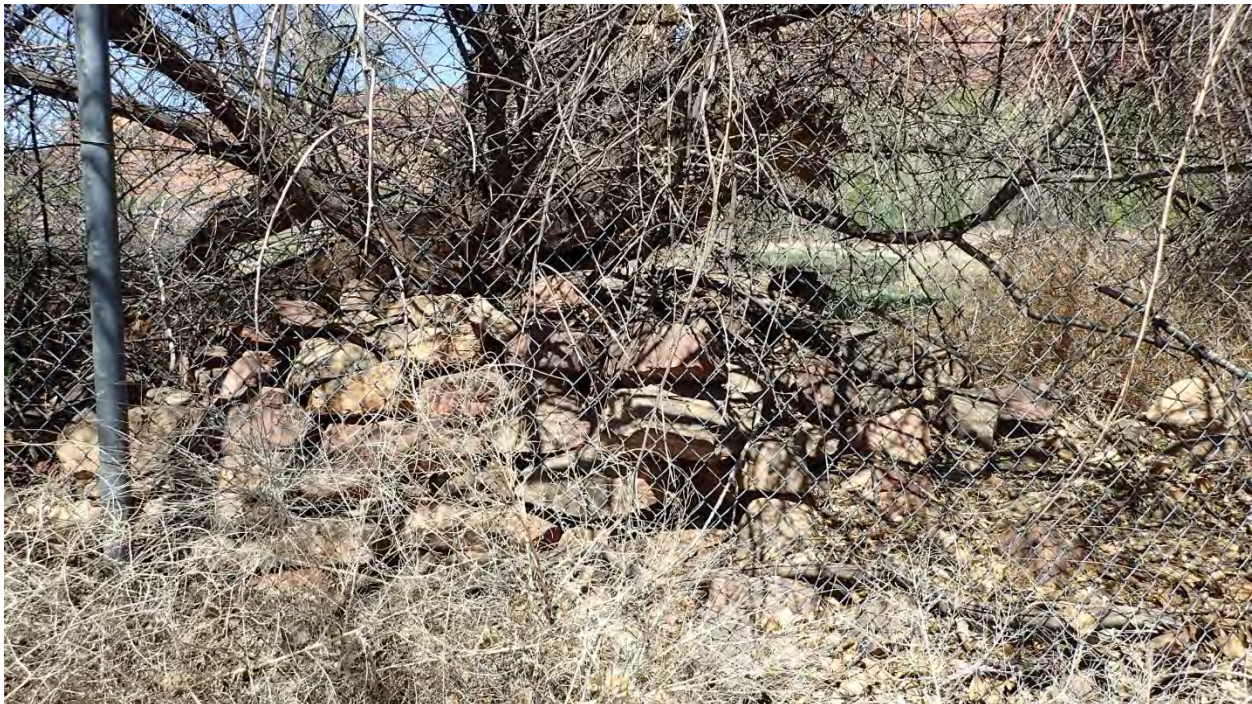
Figure 5-13. Overview of south wall of Elk Mountain Mission Fort Site (42GR5569).

A portion of the south wall and a short section of the adjoining west wall are the only visible remnants of the site. The south wall remnant is approximately 50 feet long and approximately 2 feet wide, with a maximum height of approximately 5 feet (**Figure 5-13**). The west wall remnant, one stone or 6 inches high, extends north for approximately 10 feet from the west end of the south wall. Both walls are constructed of dry laid, unshaped blocks of local sandstone. The extant walls, especially the west wall remnant, have been significantly disturbed by several cottonwood trees (**Figure 5-12**). The north and east walls may no longer exist, be buried, or are obscured by thick vegetation. No artifacts, historic or modern, were observed in association with the wall remnants. A wooden post, 6 inches in diameter and 3 feet tall, stands upright at the east of the south wall. Its function is unknown.

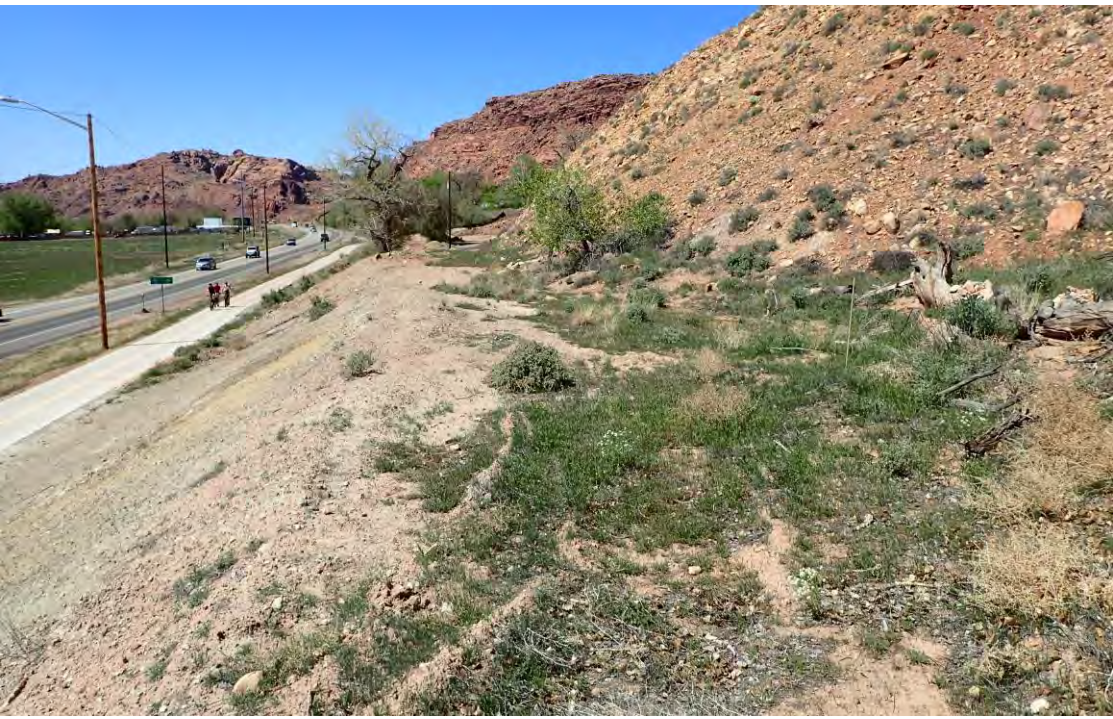
AECOM		PHOTOGRAPHIC LOG	
Client Name: UDOT		Project: US-191 Moab to Colorado River Bridge	
Photo No.: P4090037		Project No.: 60565564	
Date: 4/9/18

Site Number: 42GR2813			
Description: View looking north of a previously recorded segment of historic Moab-Thompson Wagon Road. This is the southernmost segment, which was severely altered by the adjacent bike bath.

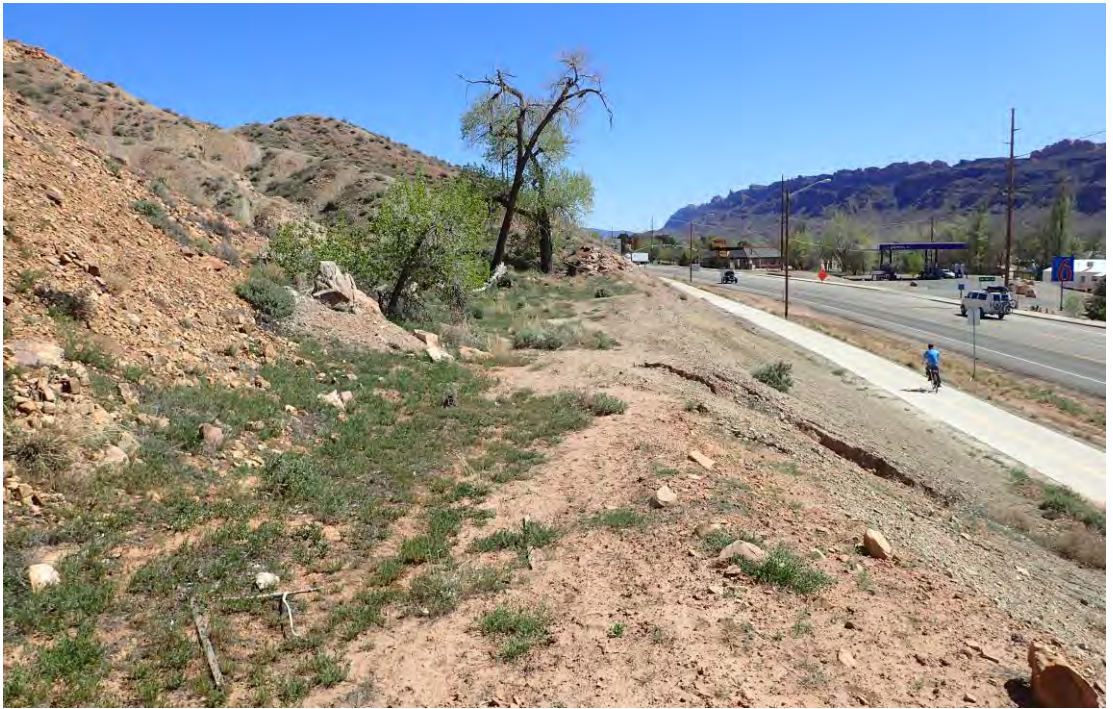
AECOM		PHOTOGRAPHIC LOG	
Client Name: UDOT		Project: US-191 Moab to Colorado River Bridge	
Photo No.: P4090038		Project No.: 60565564	
Date: 4/9/18

Site Number: 42GR2813			
Description: View looking south of a previously recorded segment of historic Moab-Thompson Wagon Road. This is the southernmost segment, which was severely altered by the adjacent bike bath.

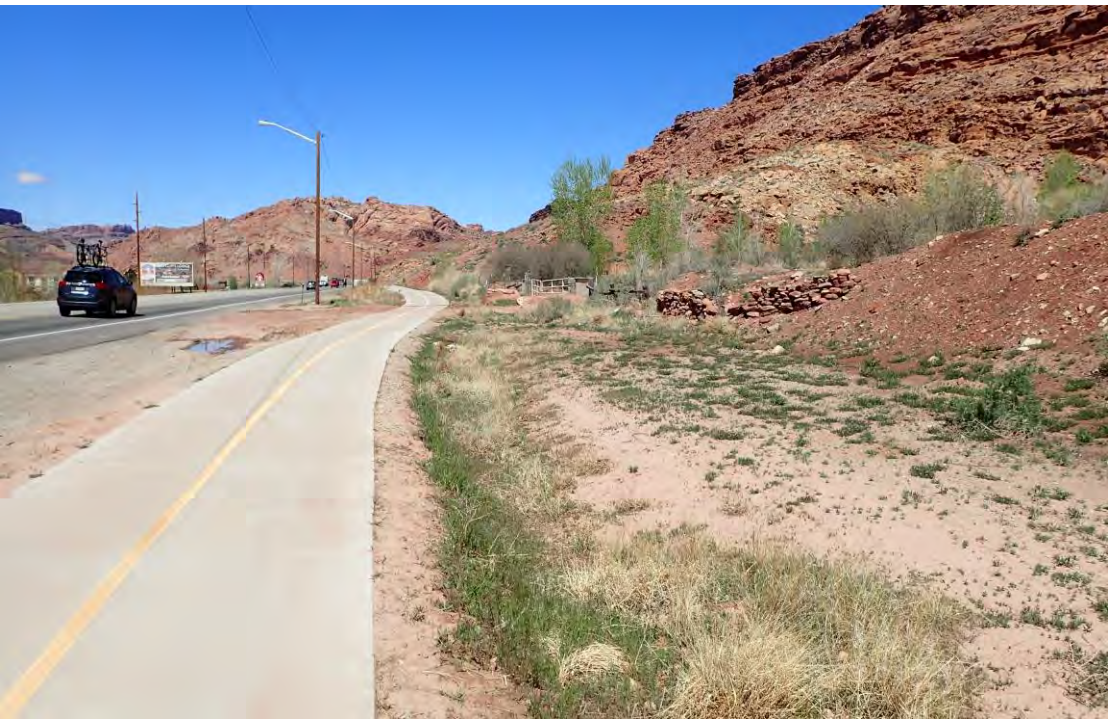
AECOM		PHOTOGRAPHIC LOG	
Client Name: UDOT		Project: US-191 Moab to Colorado River Bridge	
		Project No.: 60565564	
Photo No.: P4090019	Date: 4/9/18

Site Number: 42GR2813			
Description: View looking north of newly recorded rock wall, possibly a segment of historic Moab-Thompson Wagon Road. This segment is located at the northern end of the project area.

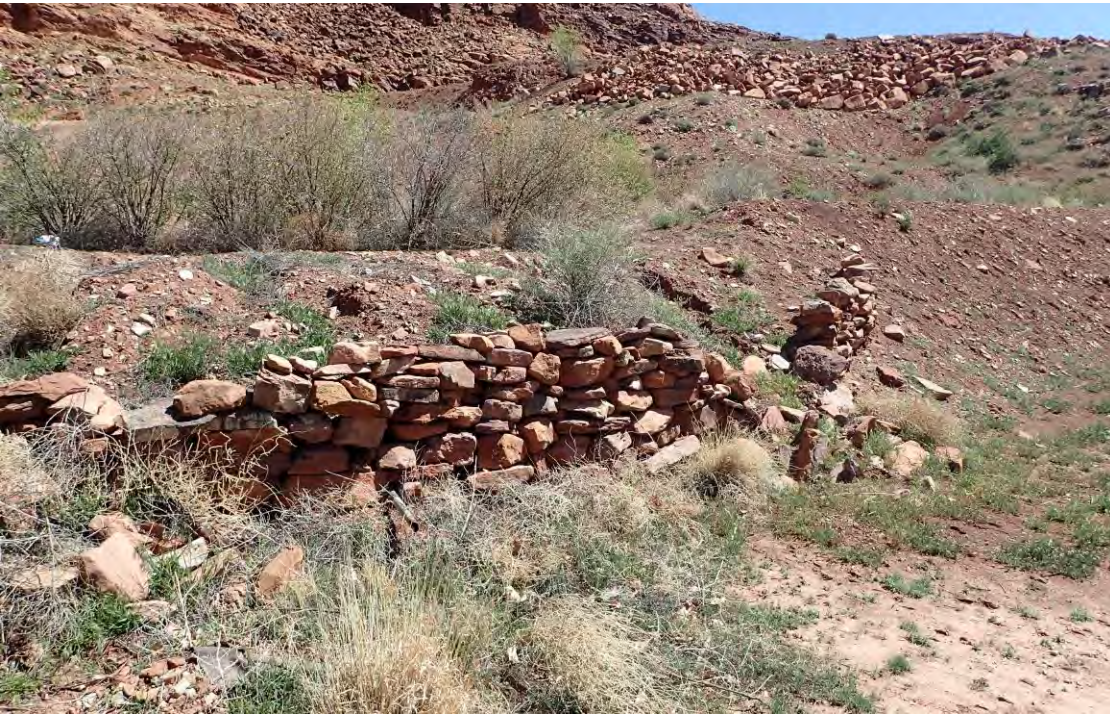
AECOM		PHOTOGRAPHIC LOG	
Client Name:		Project: US-191 Moab to Colorado River Bridge	
		Project No.: 60565564	
Photo No.: P4090018	Date: 4/9/18

Site Number: 42GR2813			
Description: View looking east of newly recorded rock wall, possibly a segment of historic Moab-Thompson Wagon Road. This segment is located at the northern end of the project area.

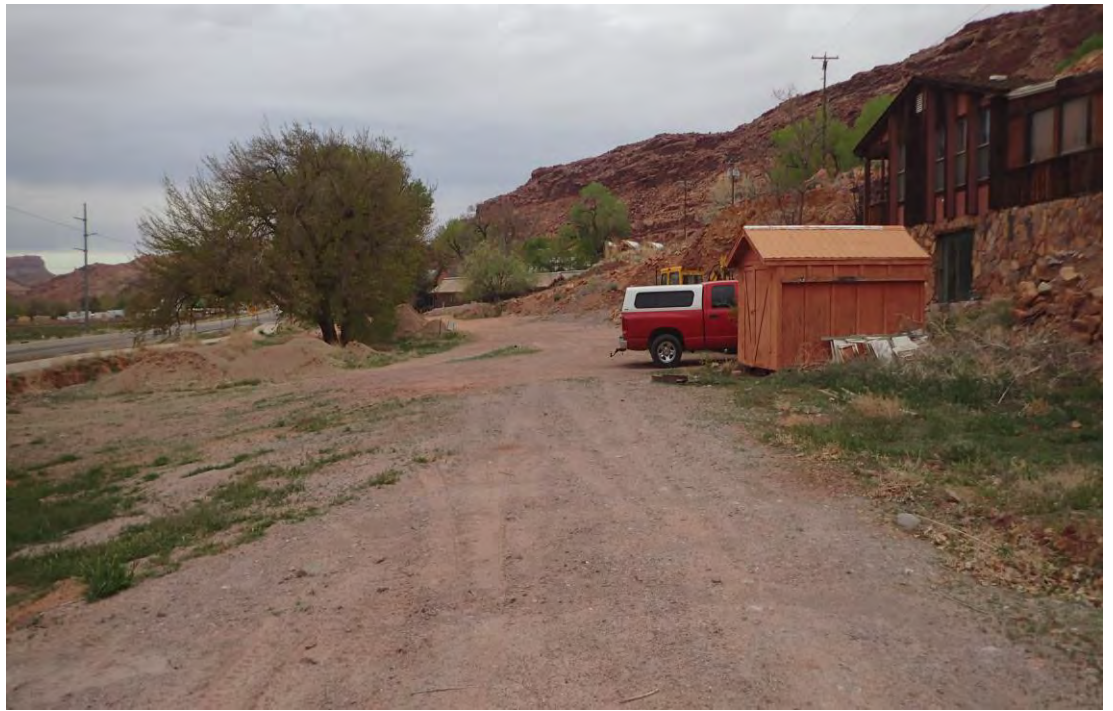
Description:
View looking north of access road to modern residence at 1050 N. Main, previously recorded as a segment of the historic Moab-Thompson Wagon Road. This segment is outside the APE.

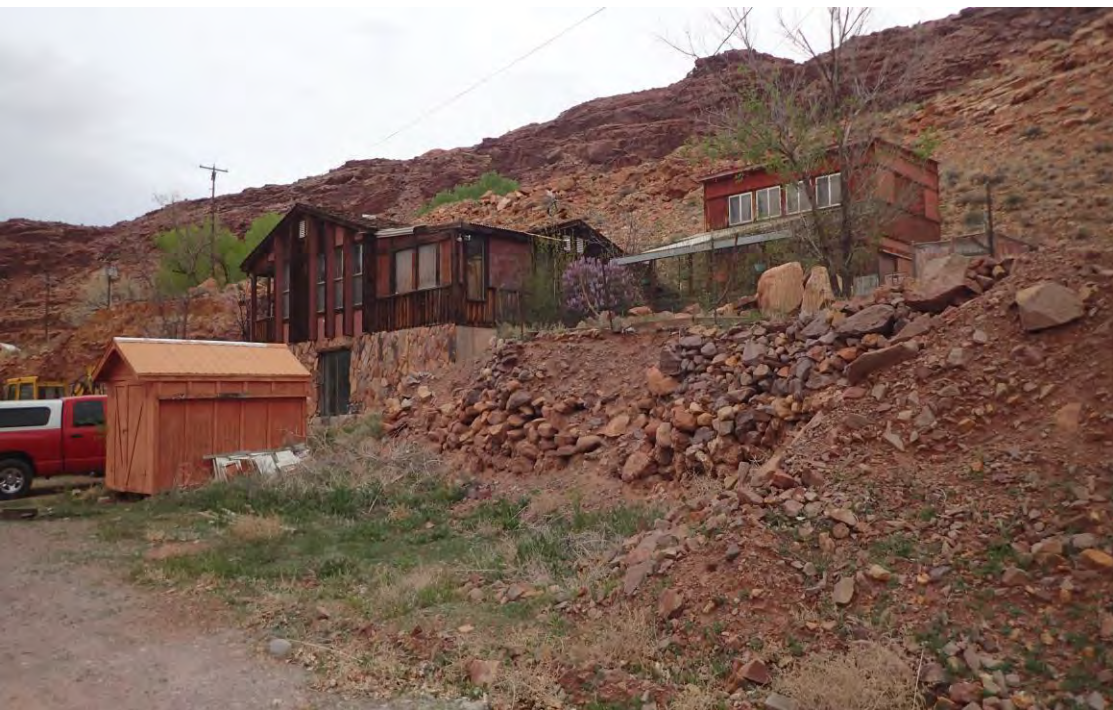
Site Number: 42GR2813

Description:
View looking northeast of rock retaining wall for modern residence at 1050 N. Main, possibly associated with the historic Moab-Thompson Wagon Road. This segment is outside the APE.

Site consists of several segments of the historic Moab-Thompson wagon road, which was in use from 1883 to 1919 when it was replaced by a federally funded highway. Five segments of the road were originally documented in 1997 and lie north of the current APE. Additional segments were documented more recently on the east side of US191 near the current APE. Two segments, both labeled Feature A, were documented in 2005. The northern segment was described as coinciding with the driveway to the residence located at 1050 N. Main. This segment is distinguished by a stacked sandstone rock retaining wall for the residence, which ranges in height from 3 to 10 feet. It has eroded in places and been impacted by the modern residence and driveway. The southern segment was described in 2005 as approximately 6.5 feet wide and situated between two small finger ridges, approximately 150-200 feet south of the northern segment. The southern segment was reported in 2011 as having been destroyed by construction of a nearby bike/pedestrian path, and these circumstances were confirmed during the current survey. Near the northern end of the current APE, a previously undocumented section of rock wall that may be part of the historic wagon road was recorded. This feature is approximately 30 feet long, 12 inches wide, and curves slightly to the east. It is approximately 4 feet tall, with 8 to 9 courses of local sandstone. The wall has collapsed in the center. A level area east of rock wall may be a roadbed remnant. This wall may have been built for another purpose, but based on historical maps, the wall is in the correct location to be associated with the Moab-Thompson road and its construction of dry laid blocks of local sandstone is similar to other segments.

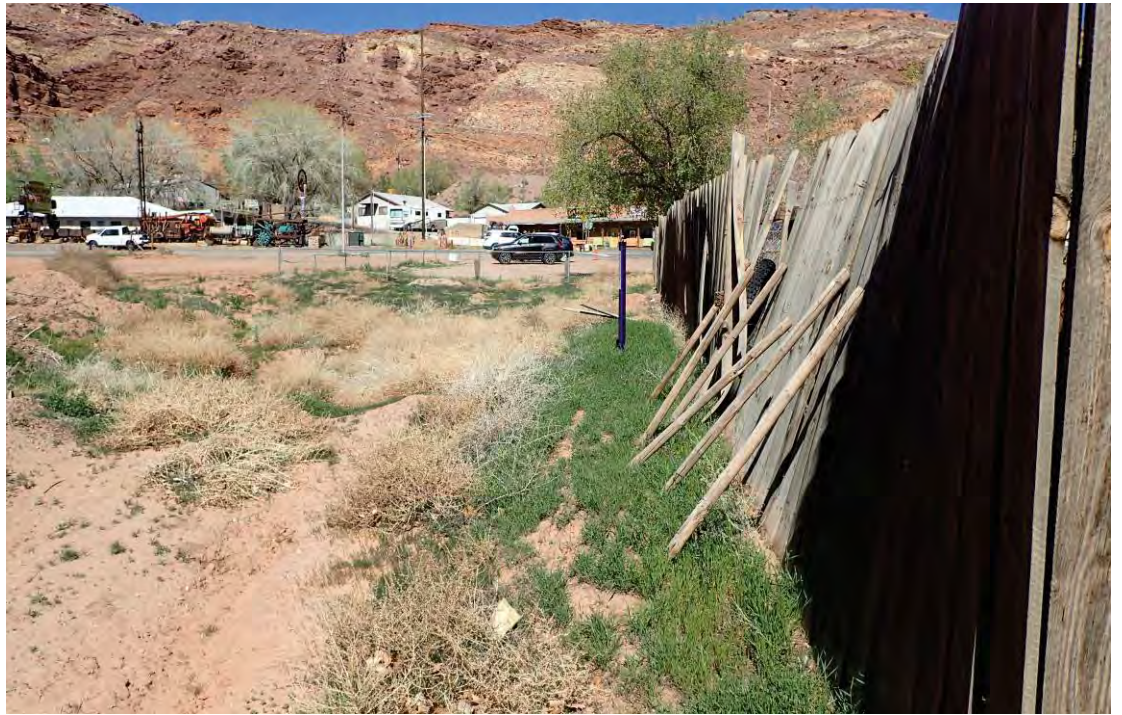
Client Name:
UDOT**Project:**
US-191 Moab to Colorado River Bridge**Project No.:**
60565564**Photo No.:**
P4090039**Date:**
4/9/18**Site Number:**
42GR3622**Description:**
View of recorded historic
ditch, next to fence,
looking ENE.

The site was described in 2005 as a shallow, earthen ditch, which is approximately 50 feet long, 3.3 feet wide, and 1.5 feet deep. It was overgrown with weeds and grass and contained no water. No artifacts were found in association with the ditch. Recent disturbance in the area has removed any evidence of the ditch.

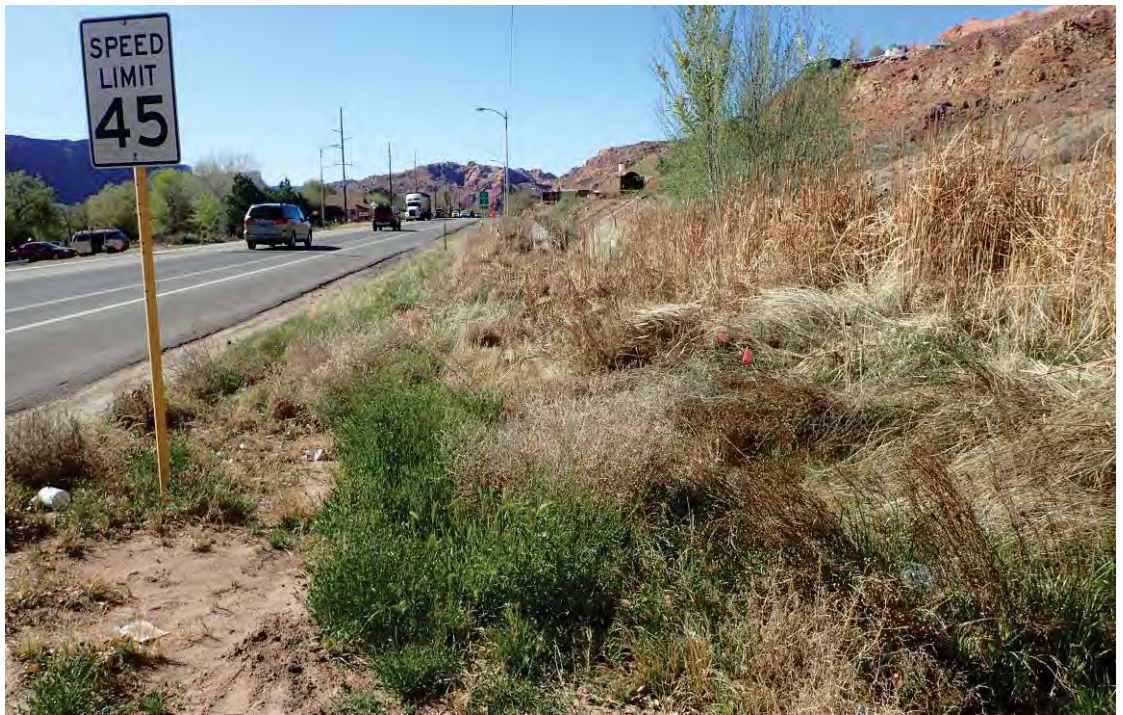
Site Number:
42GR3623

Description:
View looking north of the Present Route of the historic ditch, east side of North Main.

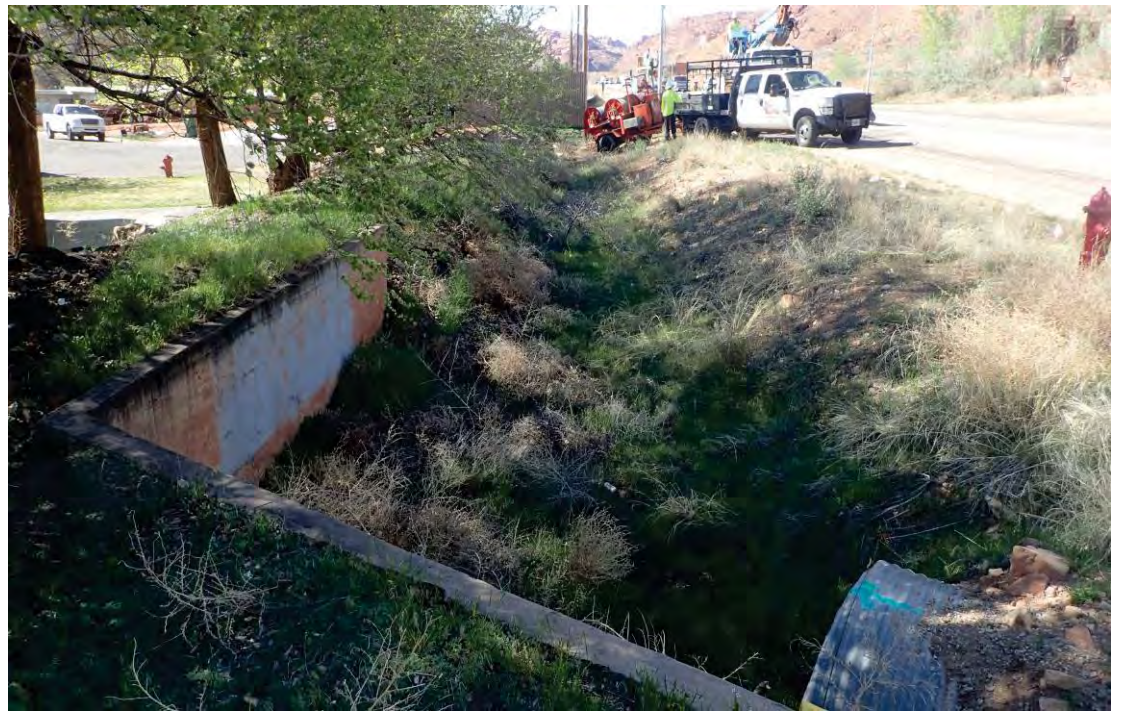
Site Number:
42GR3623

Description:
View looking NW of historic ditch, Feature B, west side of North Main.

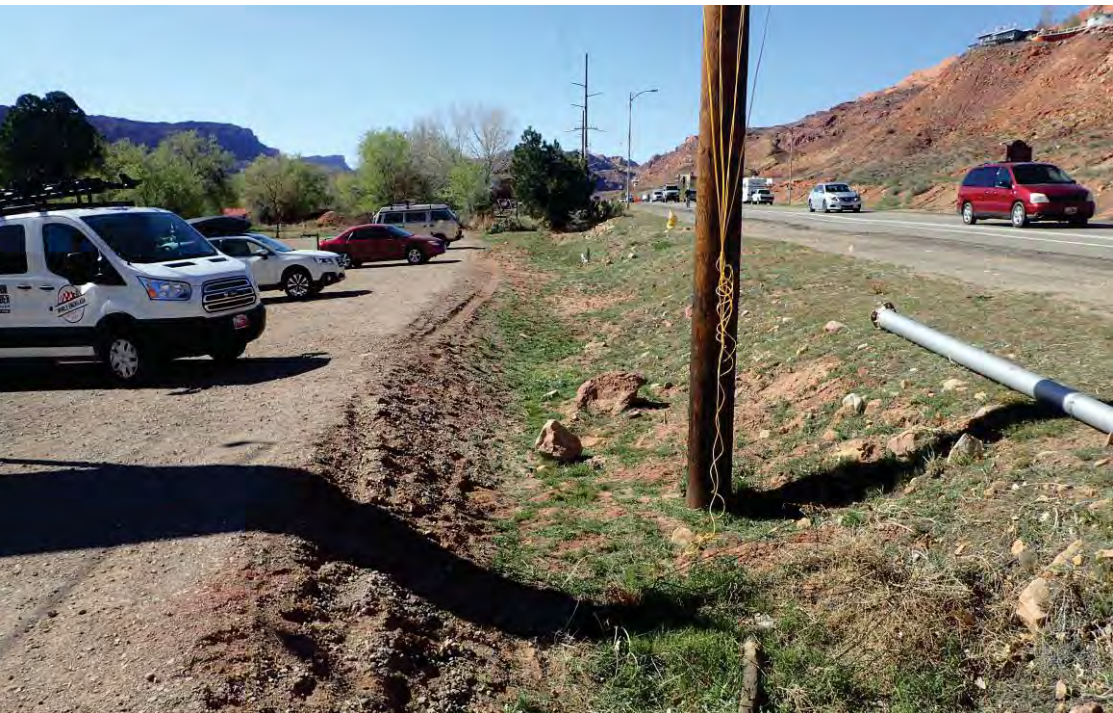
Site Number: 42GR3623			
Description: View looking NE of the Original Route of historic ditch, west side of North Main, immediately north of point where the Original Route and Present Route come together.

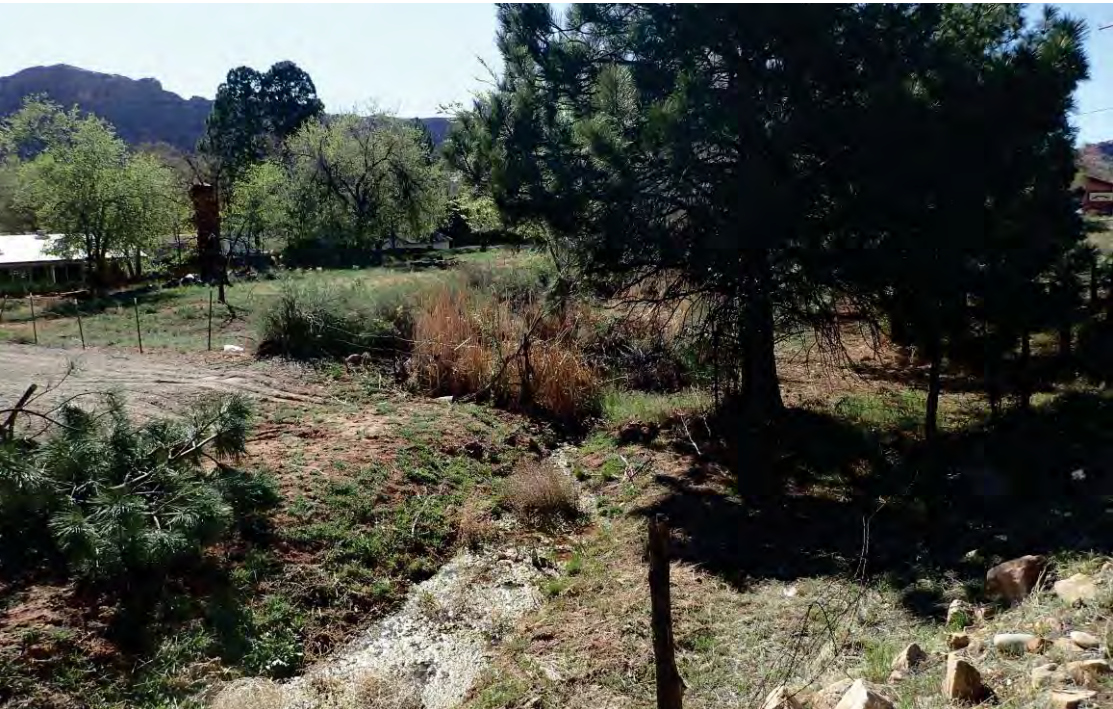
Site Number: 42GR3623			
Description: View looking NW of historic ditch, where the combined channel curves away from North Main.

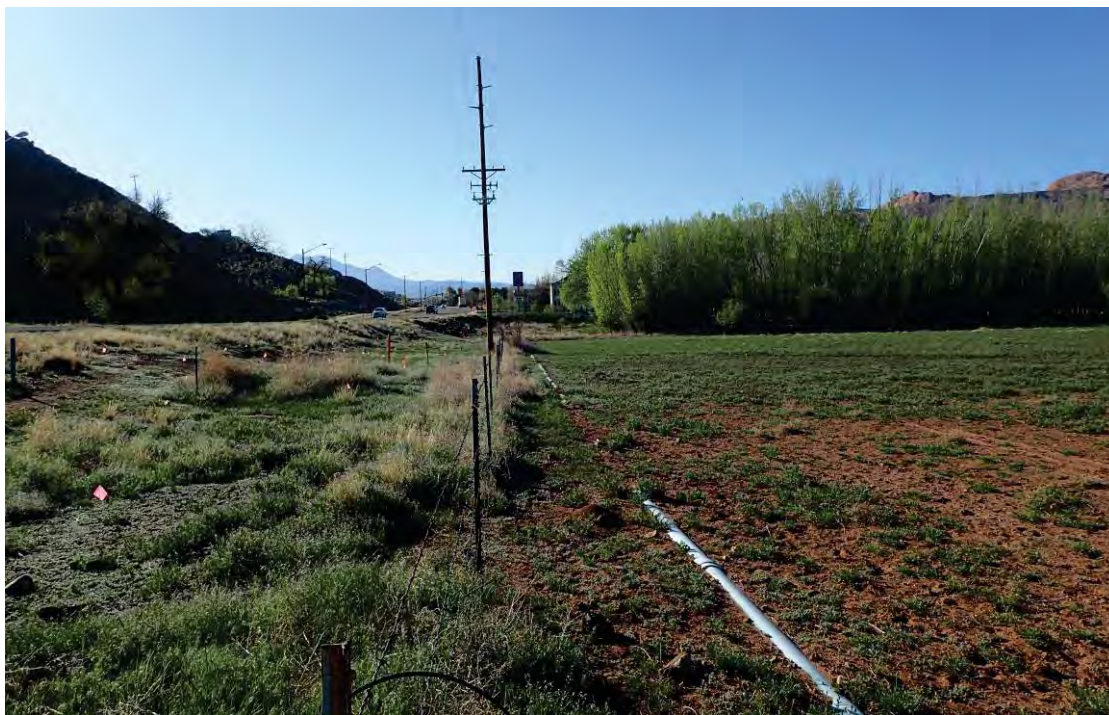
Site Number:
42GR3625

Description:
View of historic ditch, south of headgate, looking SE. Note ditch has been replaced with PVC pipe.

Site is described as a historic ditch, which originates at a natural spring on the historic Arthur Taylor property, east of US 191. Water from the spring flows into a metal grate east of the highway (Feature C), continues underneath the highway in a small (12-inch) diameter culvert (Feature B), and exits into a concrete headgate (Feature A), which diverts water to the north and south along the west side of the highway. The original channel is present north of the headgate, but the channel south of the headgate has been replaced with a 10-inch diameter PVC pipe. Water fills the headgate and is presently used as a watering trough for horses, within an enclosure formed of wooden posts and straight wire. Water overtops the headgate and flows west to a point just outside the enclosure, where it has been recently diverted north and south into two hand-dug channels that irrigate the agricultural field. A possible second headgate (Feature D) was discovered during the current investigations, located approximately 300 feet southeast of Feature A and 30 feet southeast of metal gate and access road to the agricultural field. Feature D is visible as the top of a concrete wall, 10 inches wide, with a total length of 10 feet. The first section of this concrete wall is 6 feet long and runs parallel to the barbed wire fence on the western edge of the highway right-of-way; the wall then angles toward the highway and continues for another 4 feet. On the west side of the right-of-way fence, the top of a second concrete wall, 6 inches wide and 6 feet long, is visible. A large chunk of concrete lies next to this second wall segment.

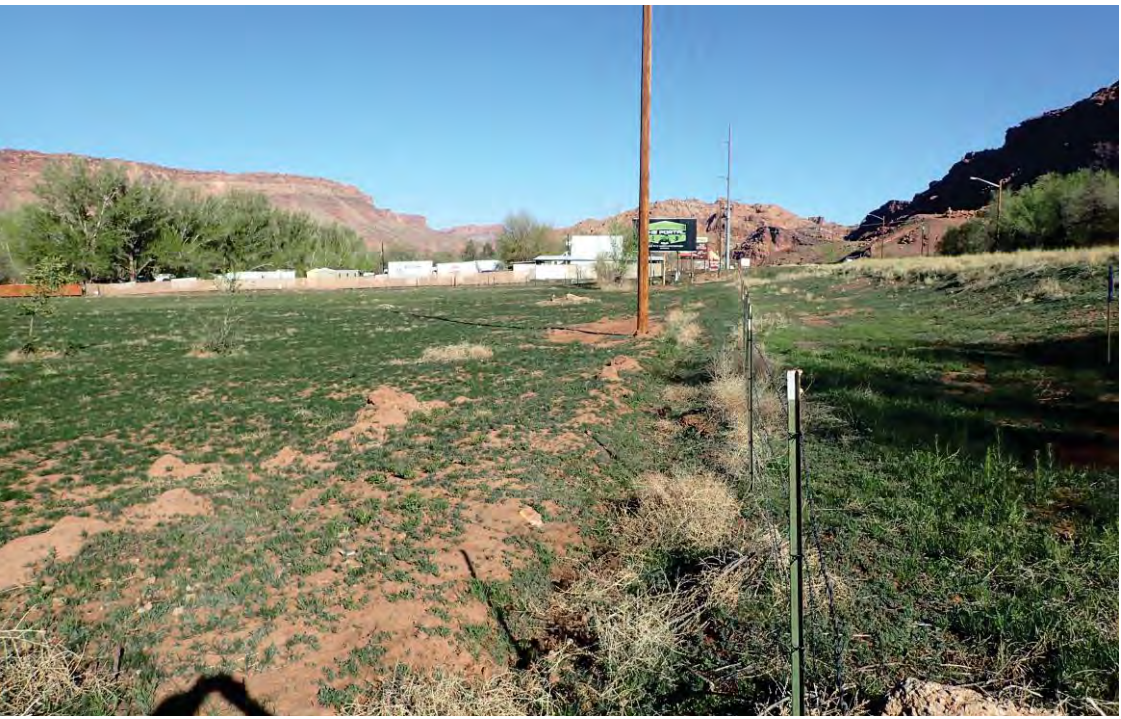
Site Number: 42GR3625			
Description: View of historic ditch, north of headgate, looking NW.

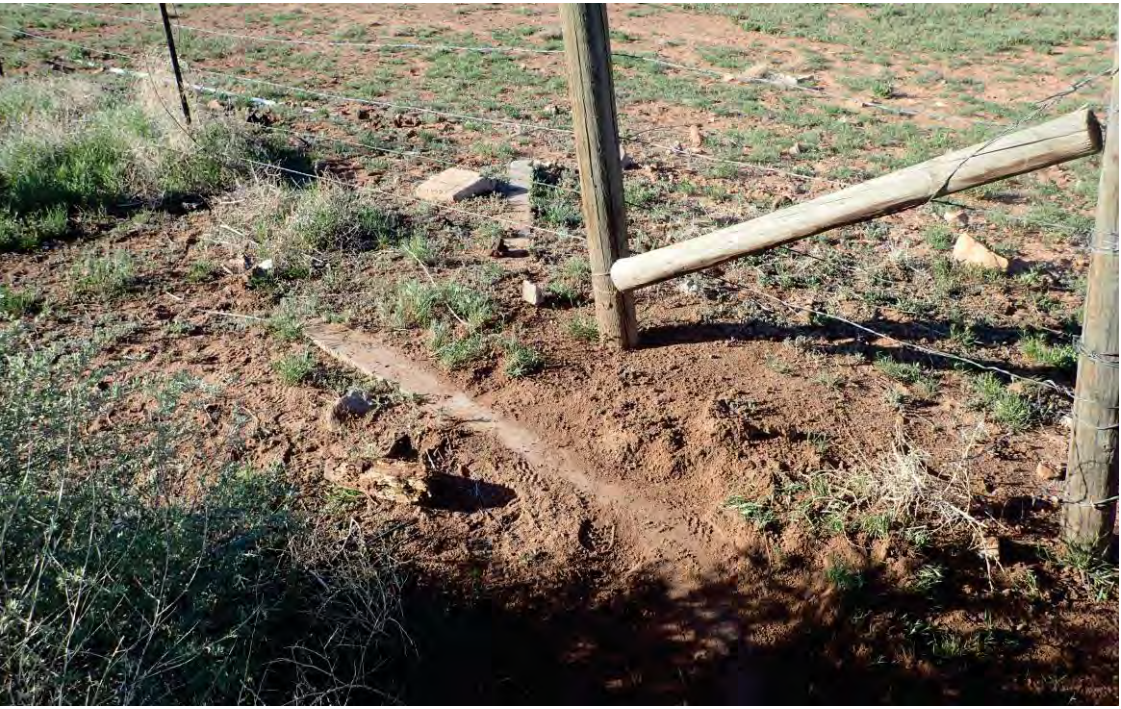
Site Number: 42GR3625			
Description: View of new concrete feature (Feature D), south of headgate (Feature A), looking south. Note sections on either side of fence and chunk of concrete.

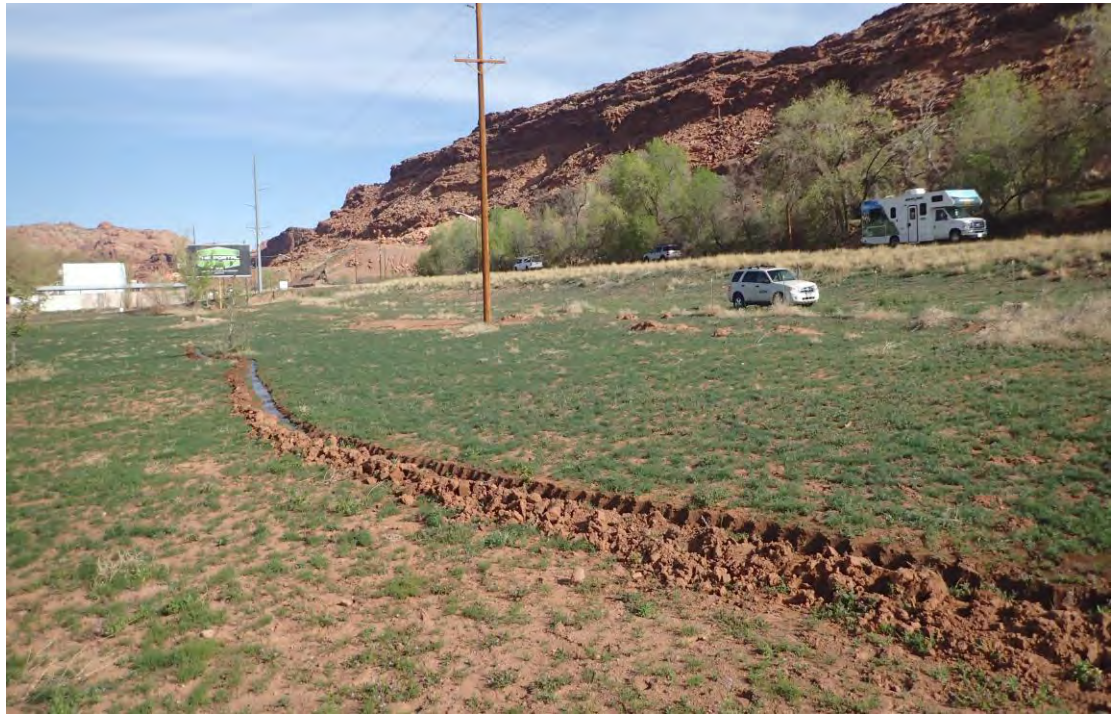
Site Number:
42GR3627

Description:
Overview of site area,
looking north. Note
hand-dug feeder lateral.

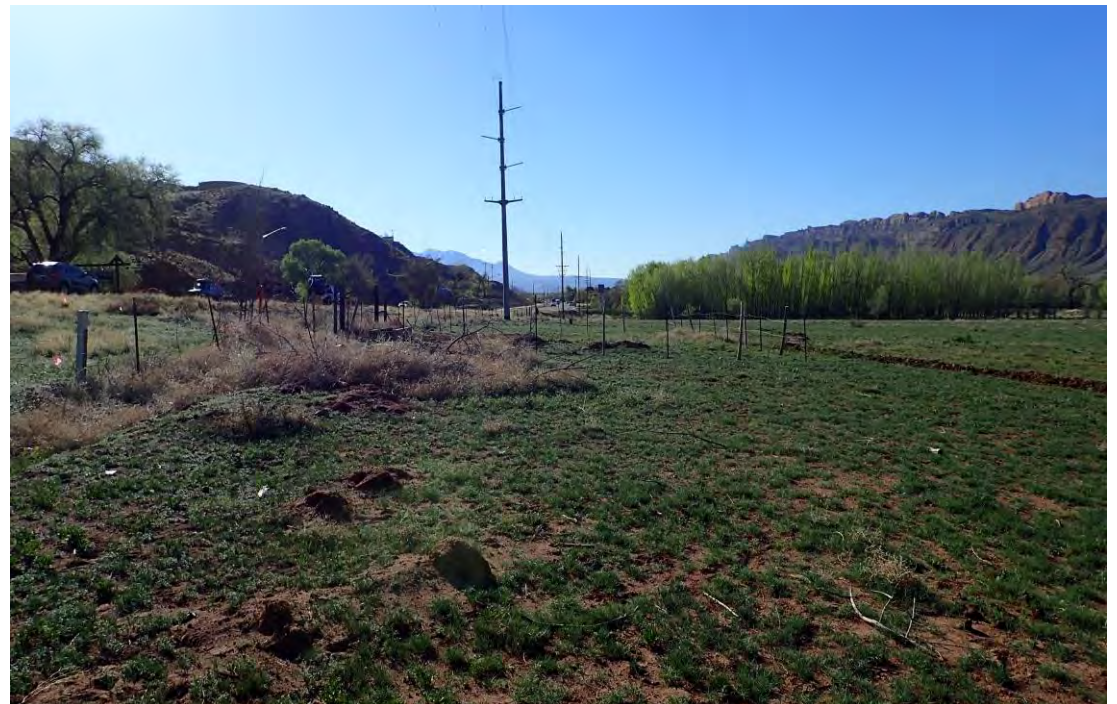
Site Number:
42GR3627

Description:
Overview of site area,
looking SE. Historic
ditch (42GR325) at left
and wire enclosure
around headgate
(Feature A) for ditch.
