Subject: UDOT Project Number F-0191(152)126, US-191, North Moab to Colorado River Bridge,
Grand County, Utah (PIN 15329)
Environmental Assessment Re-evaluation

A Final Environmental Assessment (EA) and Programmatic Section 4(f) Evaluation for the US-191 Colorado Bridge For Bridge/Roadway Reconstruction and Widening on US-191, from 400 North in Moab City to SR-279 (Potash Road), Grand County, was completed (2007) and approved through the issuance of a Finding of No Significant Impact (FONSI) (May 25, 2007) from the Federal Highway Administration (FHWA). Design modifications for the current phase between State Route 128 (SR-128) and 400 North in Moab, Grand County were not included in the 2007 EA and are the subject of this EA Re-evaluation. These improvements include a new stormwater collection system, three sedimentation basins, a vegetated water quality swale, a sedimentation dropout channel, and several new outfalls.

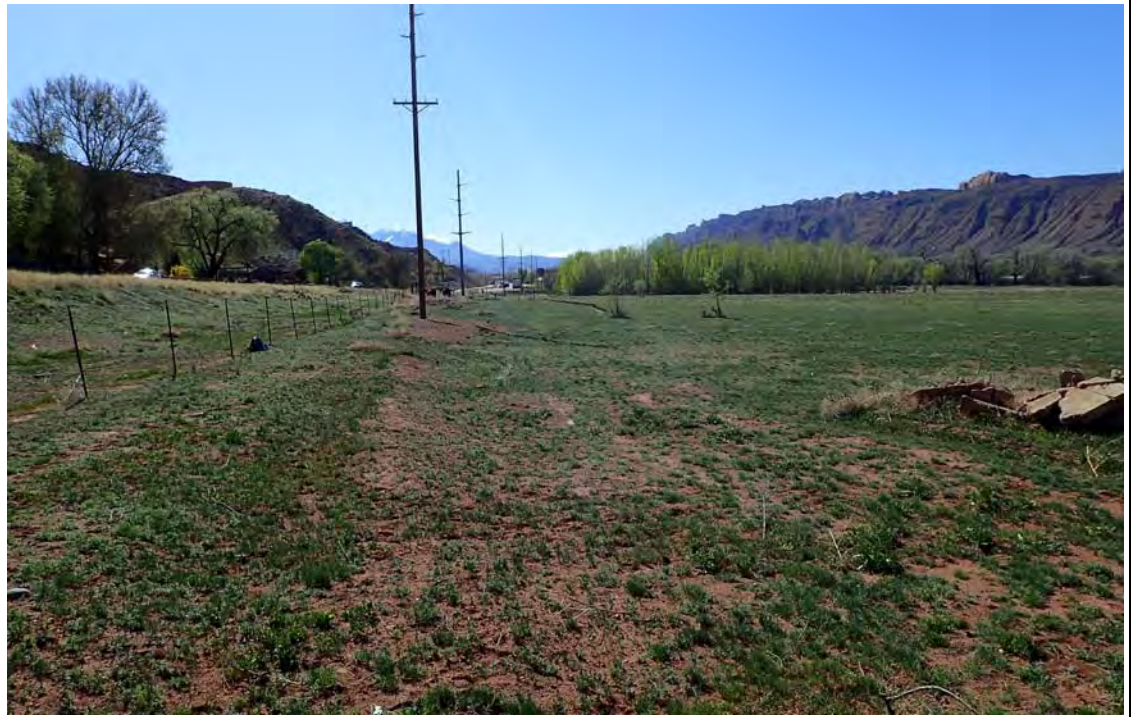
Overview of site area, looking SE. Historic irrigation ditch (42GR3625) runs parallel to right-of-way fence at left. Modern push pile at right center.

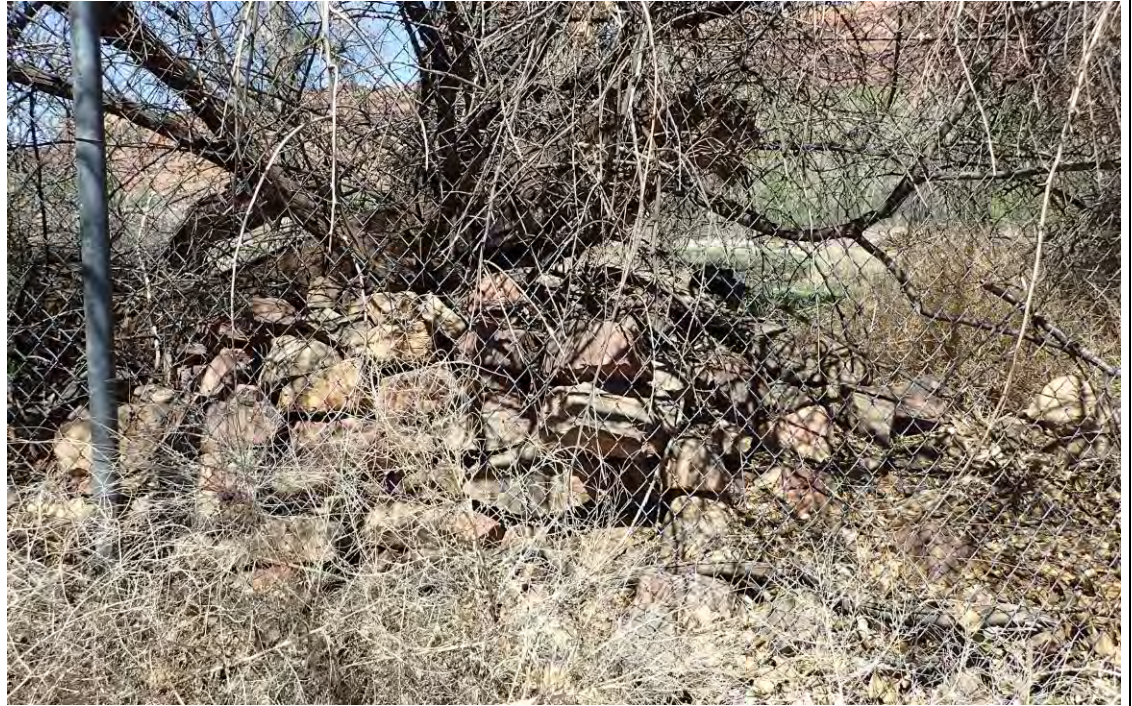
Site Number:
42GR5569

Description:
View of south wall of the Elk Mountain Mission Fort site, looking north.

The site today is visible as a portion of the south wall and a short section of the adjoining west wall. The south wall remnant is approximately 50 feet long and approximately 2 feet wide, with a maximum height of approximately 5 feet. What remains of the western wall is a loose alignment of stones, rather than a cohesive structure, which is 6 inches high and extends north for approximately 10 feet from the west end of the south wall. Both walls are constructed of dry laid, unshaped blocks of local sandstone. The extant walls, especially the west wall remnant, have been significantly disturbed by several cottonwood trees. The north and east walls may no longer exist, be buried, or obscured by thick vegetation. No artifacts, historic or modern, were observed in association with the wall remnants. A wooden post, 6 inches in diameter and 3 feet tall, stands upright at the east of the south wall. Its function is unknown.

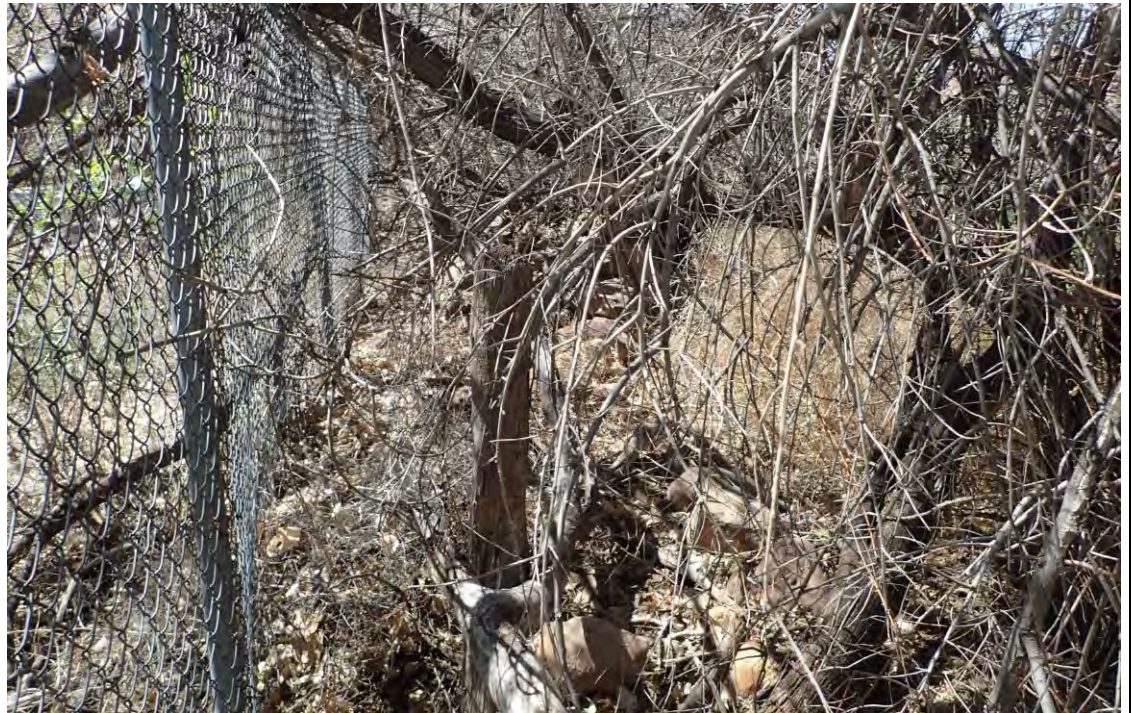
Site Number:
42GR5569

Description:
View of south wall of the Elk Mountain Mission Fort site, looking west. Note upright wooden post in center.

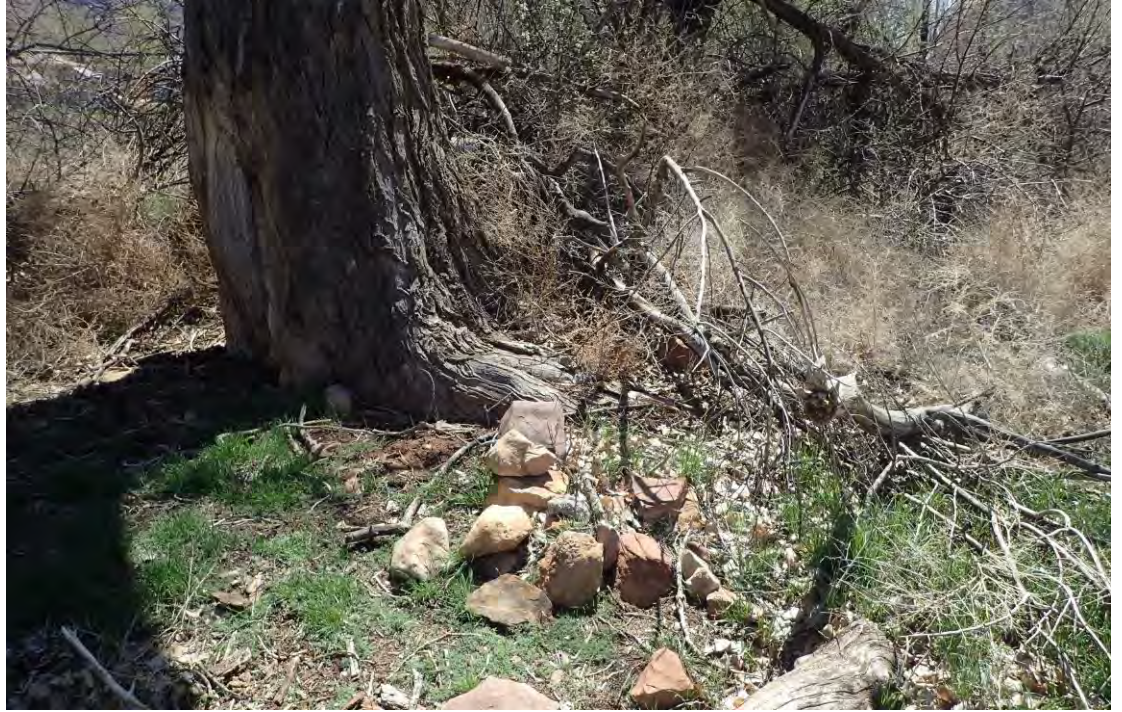
Client Name:
UDOT**Project:**
US-191 Moab to Colorado River Bridge**Project No.:**
60565564**Photo No.:**
P4090035**Date:**
4/9/18**Site Number:**
42GR5569**Description:**
View of the west wall of
the Elk Mountain
Mission Fort site,
looking south.
